Department of Trade

ACCIDENTS INVESTIGATION BRANCH

Beechcraft Super King Air 200 G-BGHR
Report on the accident near Nantes, France,
on 25 September 1979

Translation of the report by
The French Bureau Enquetes - Accidents

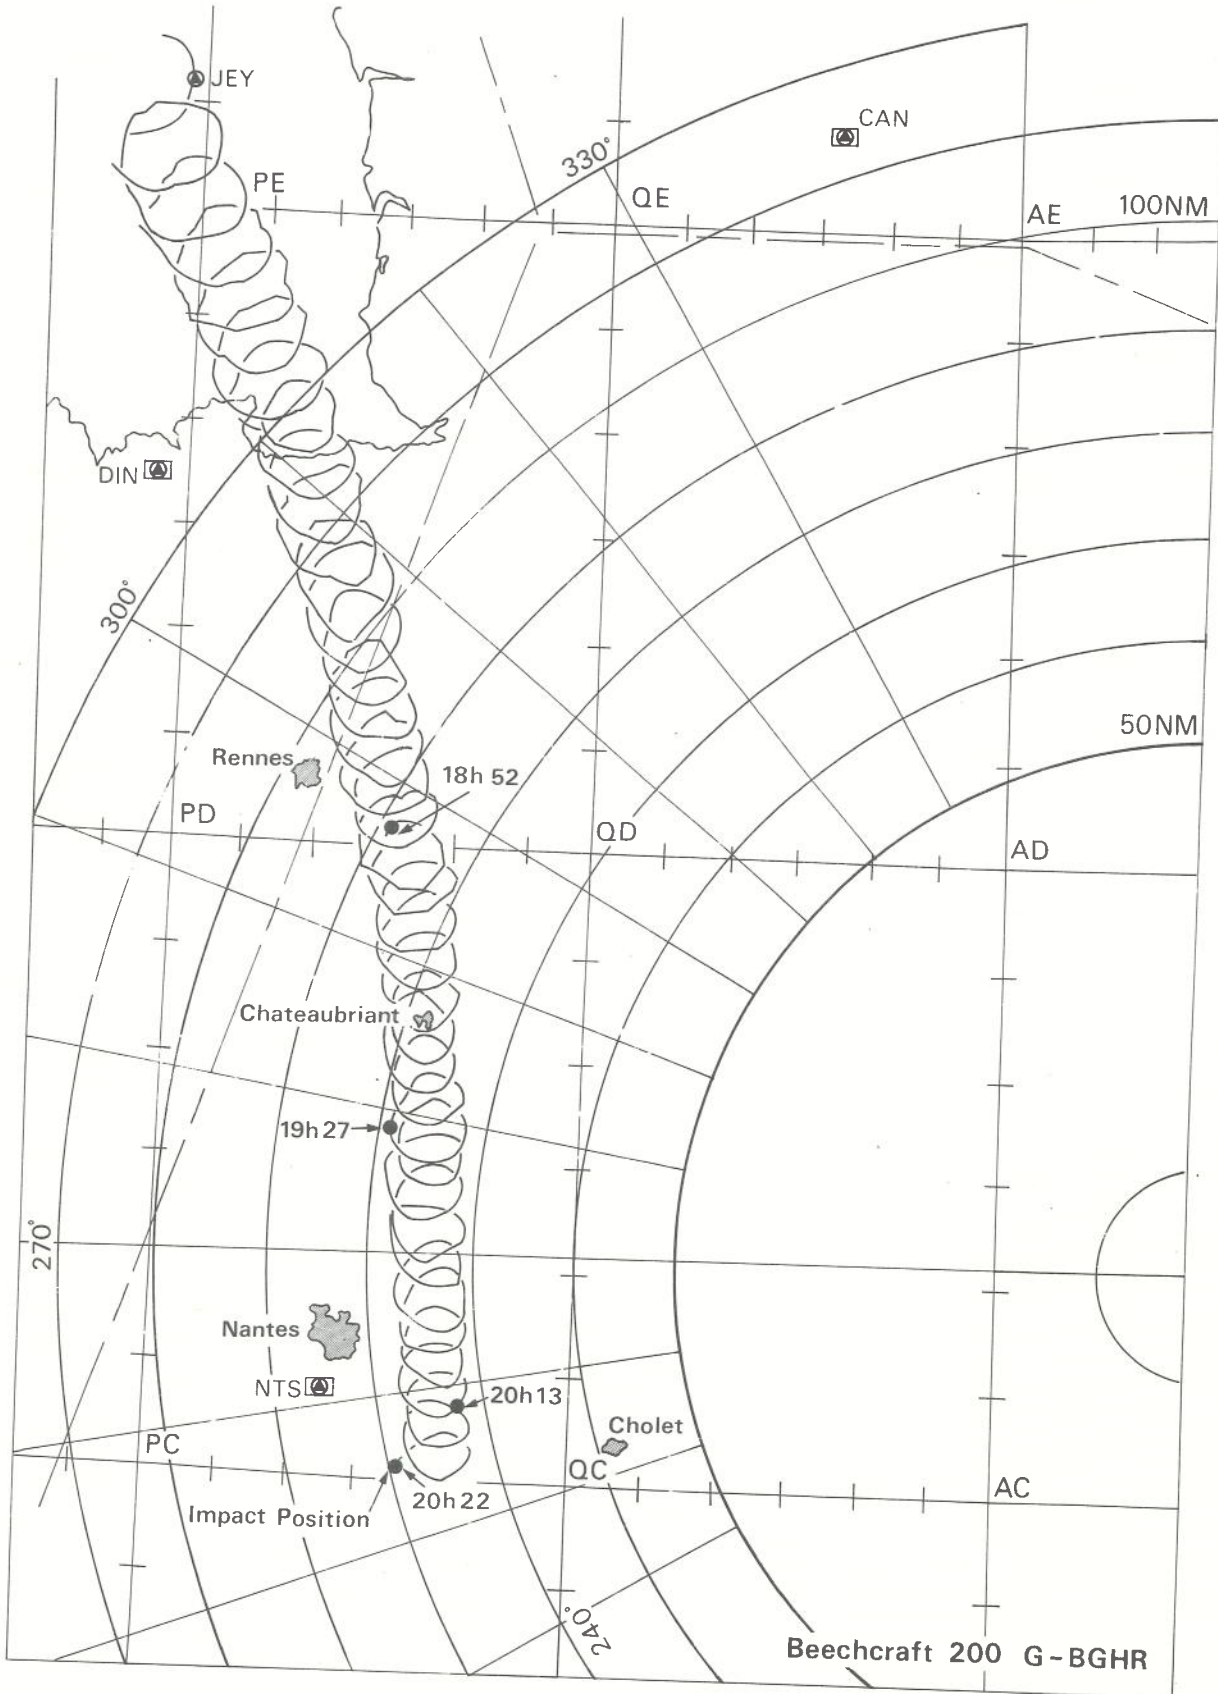
Track of G-BGHR Derived from French Radar Sources

Since 1438 hrs G-BGHR had been describing large circles to the left at FL 310 (see Appendix 1). The wind at that altitude made the aircraft drift towards the south, and it was to pass successively over Guernsey, Jersey, Dinard and Rennes. At the end of its endurance at 2020 hrs the aircraft crashed near Nantes, 20 km to the east/south east of the town.

The first circle described by the aircraft after flying over Dawlish had a radius of approximately 8.5 NM. Over Jersey, the radius had tightened to 6.5 NM and over Rennes it was down to 4 NM remaining constant thereafter until reaching Nantes. From the radar readings in the vicinity of Dawlish the ground speed can be calculated as 210 kts, the wind in that area at FL 310 was 33 knots at 320° and in these conditions the aircraft speed was 245 kts.

The flight manual gives the following data for FL 310 at 1700 propeller RPM, at a weight of 11,000 lbs in ISA + 5° conditions: IAS: 149 kts, TAS: 250 kts. At a speed of 245 kts, a turn with a radius of 8/9 NM is achieved with 5.5° of bank; over Jersey, the bank increased to 7°, and from Rennes to Nantes it was 12°, assuming constant speed with the ball centred.

However, it appears that the aircraft was flying in a skid turn. The first circle over the English coast took 12 minutes, which would have given a turn radius of 7.8 NM instead of the 8.5 NM observed. Between Rennes and Nantes, the circles took 4' 45", and the radius should have been 3.10 NM instead of 4.5 NM. In each case, the angle of the bank was therefore greater than the calculated bank. What is more, the pilots who escorted the aircraft noted a bank angle of some 30°, and an indicated speed of 140/150 kts, which matches the figures derived from the radar recording and the figures in the flight manual.
