Rail Accident Investigation Branch

Rail Accident Report

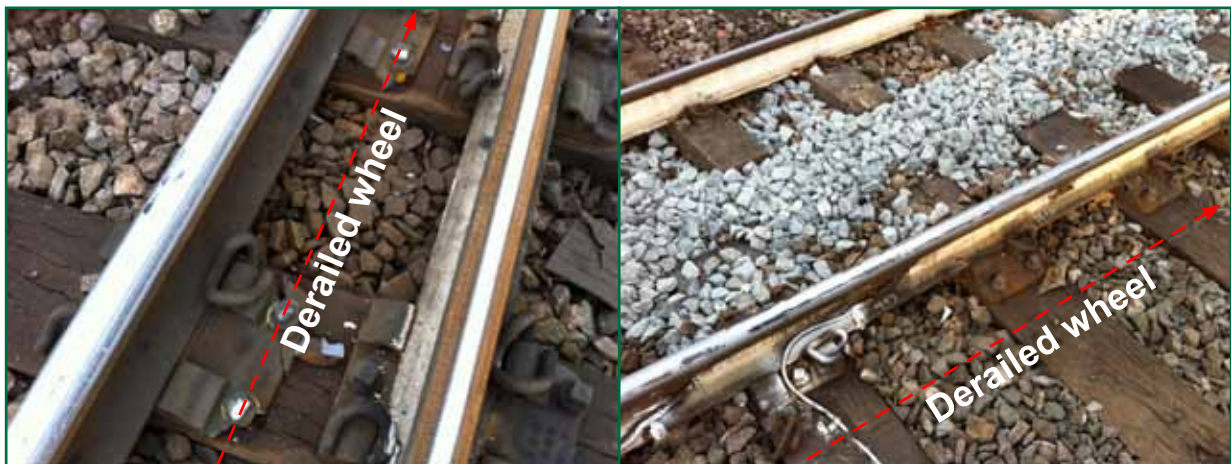
Figure 5: Damage to track and track circuit cables (photographs courtesy of Network Rail)

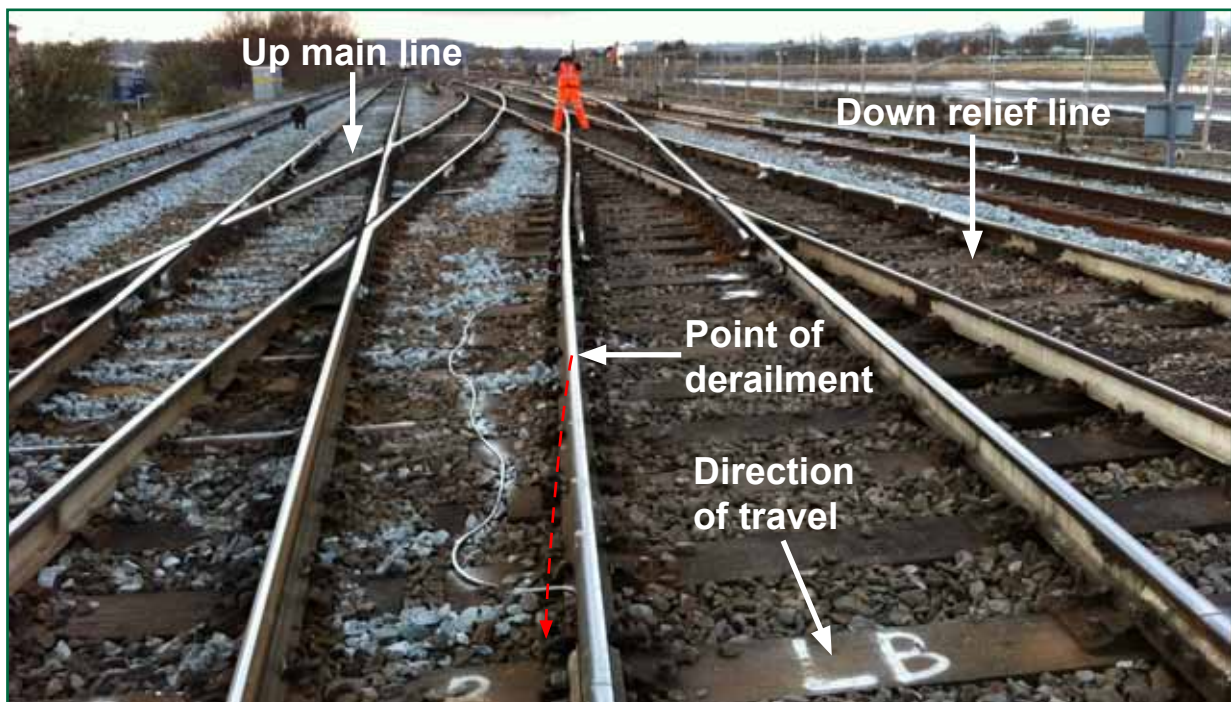
Figure 6: Location of the derailment on crossover 3717 (photograph courtesy of Network Rail)

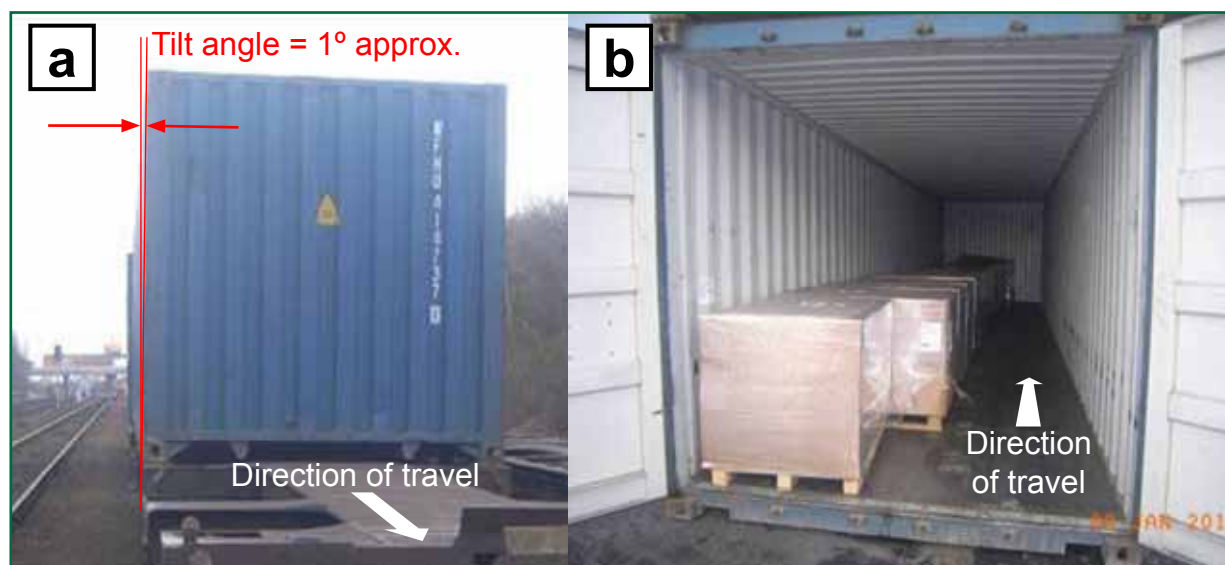
Figure 8: Container WFHU414737 showing the tilt and the location of its contents when examined at Southampton Maritime

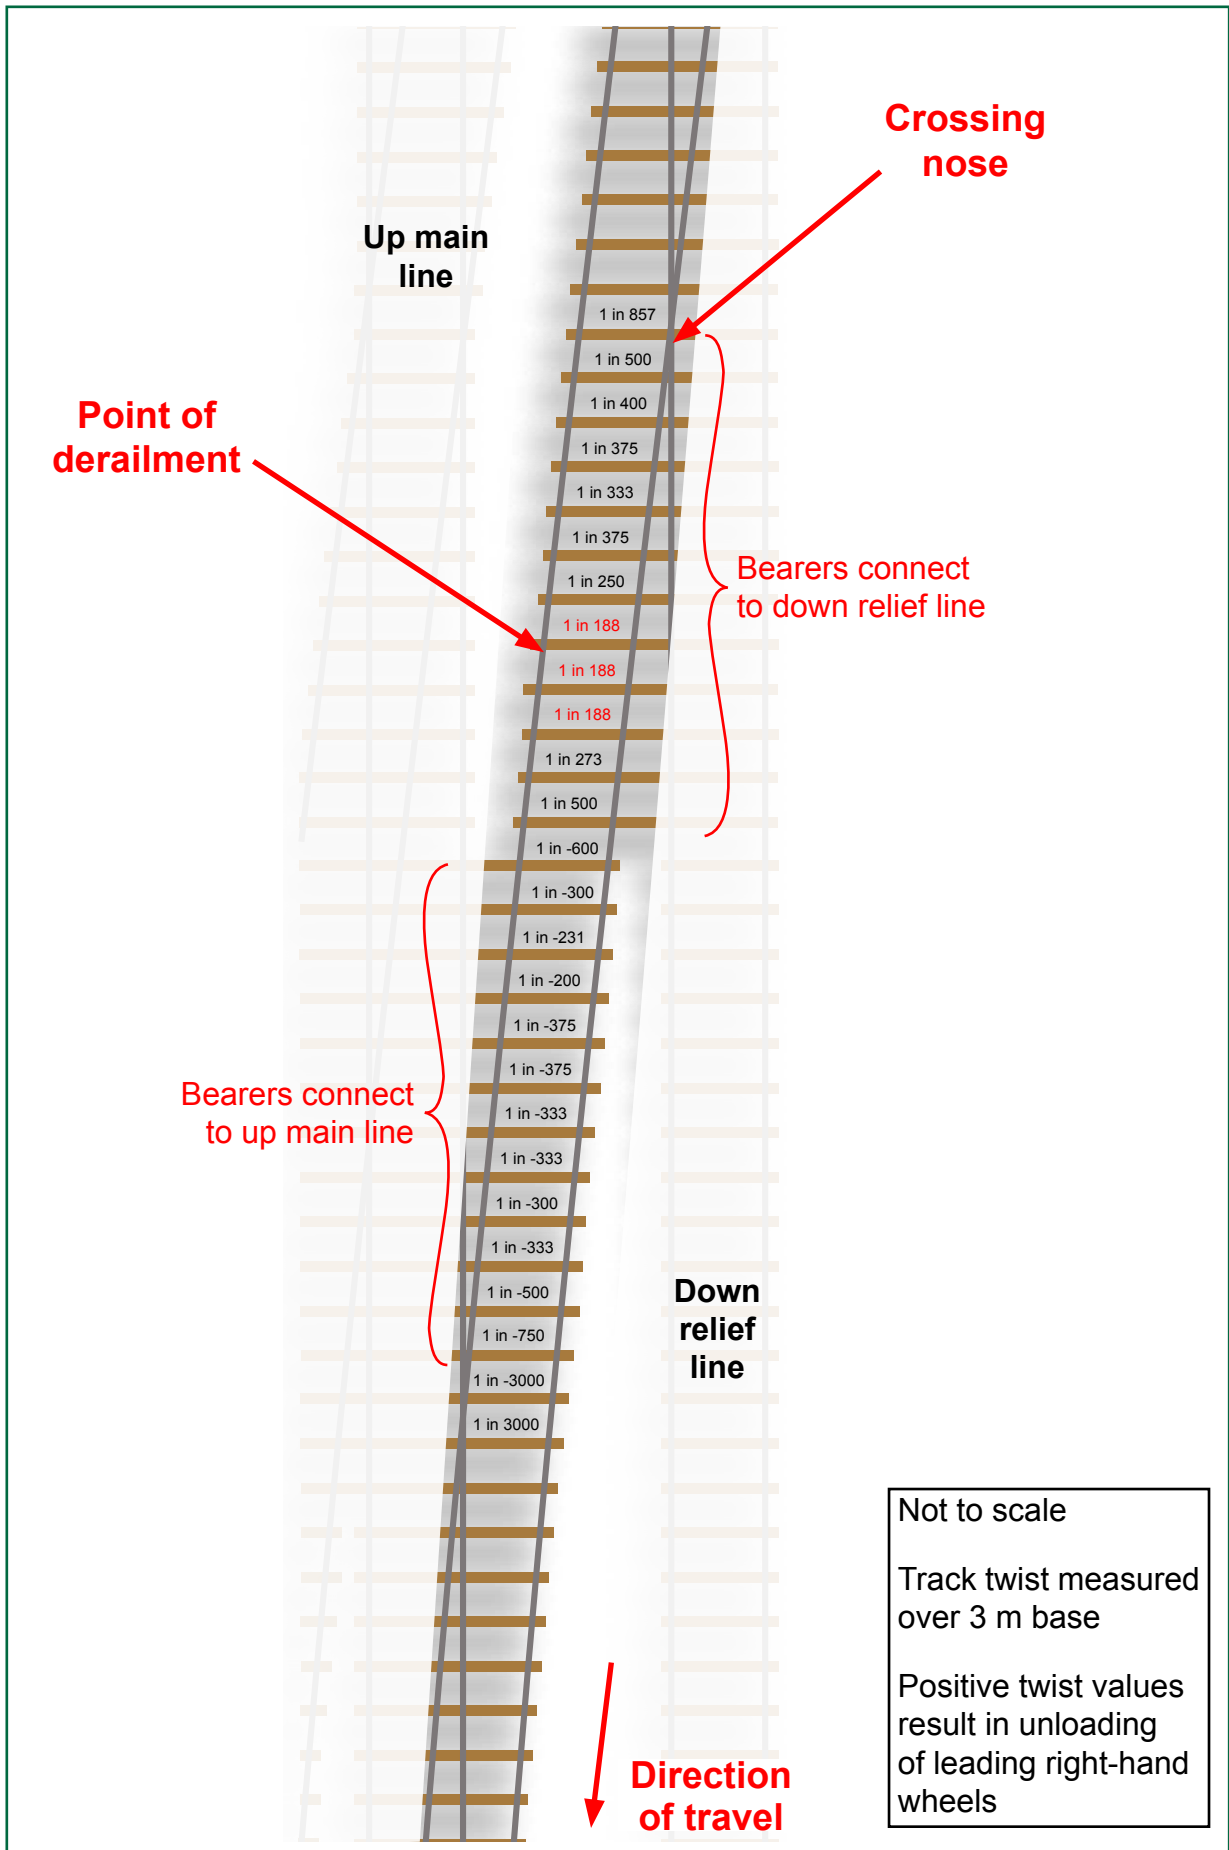
Figure 9: Track layout in the vicinity of crossover 3717 showing the measured twist values

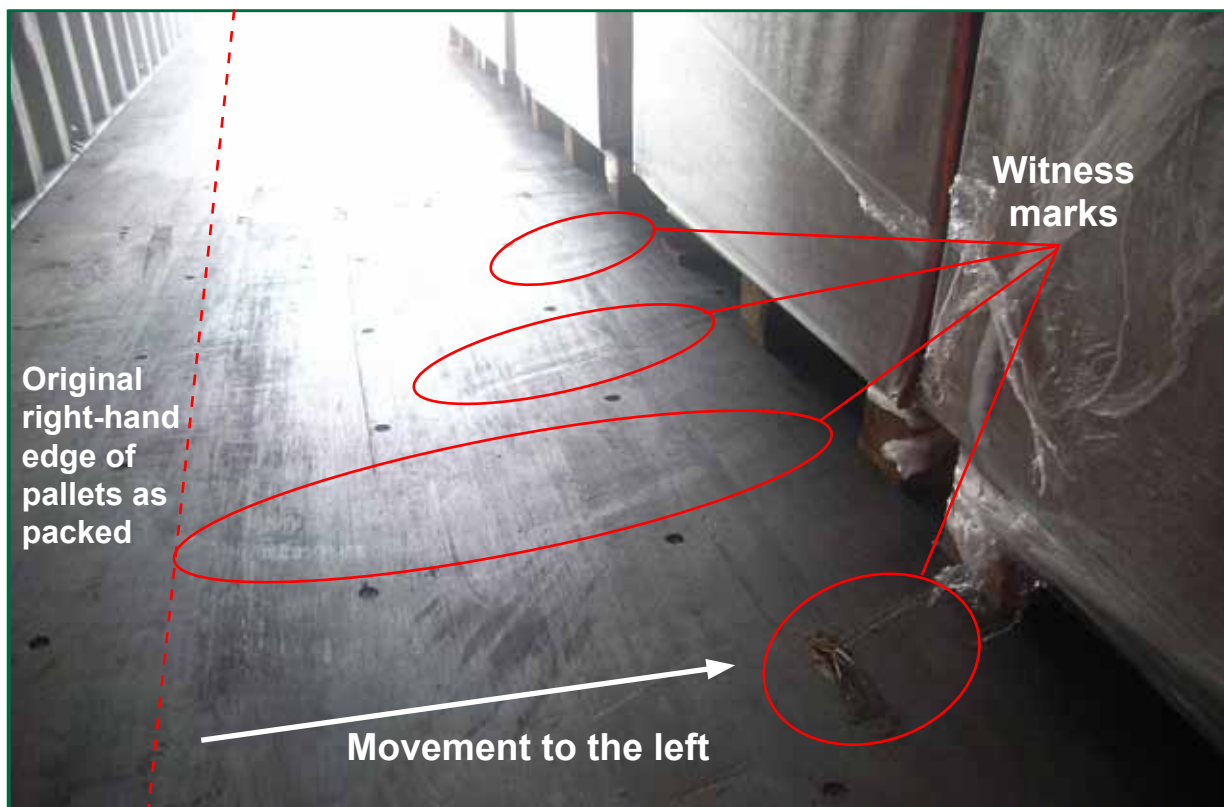
Figure 10: Witness marks on the floor of container WFHU 4147370 showing how the pallets moved

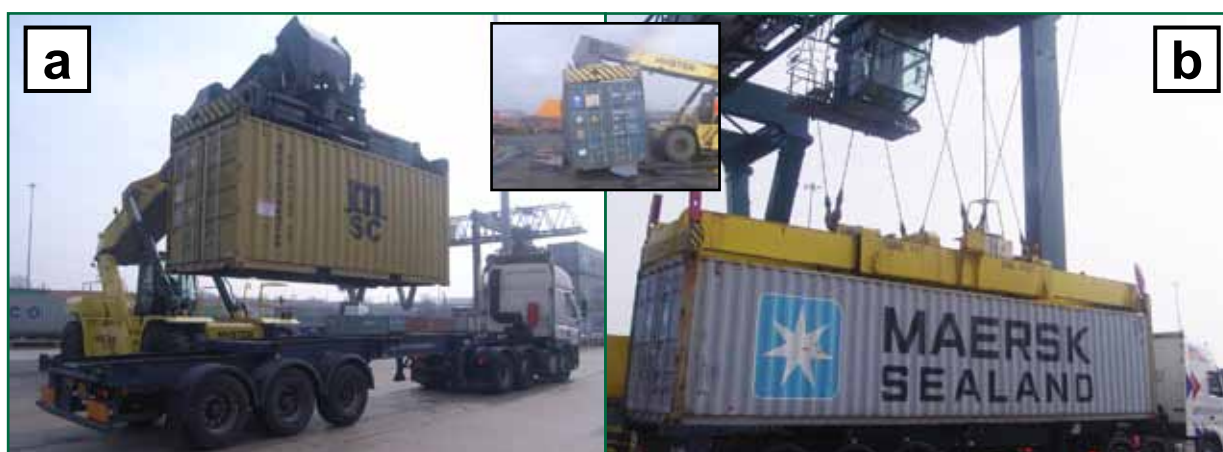
Figure 11: Reachstacker and overhead crane at Lawley Street terminal (inset shows container WFHU 4147370 tilted when it was lifted with a similar reachstacker at Southampton Maritime)
