Report on the investigation of  
the collapse of a mezzanine deck on board  
the roll-on roll-off passenger ferry  
***St Helen***

Fishbourne Ferry Terminal, Isle of Wight  
on 18 July 2014

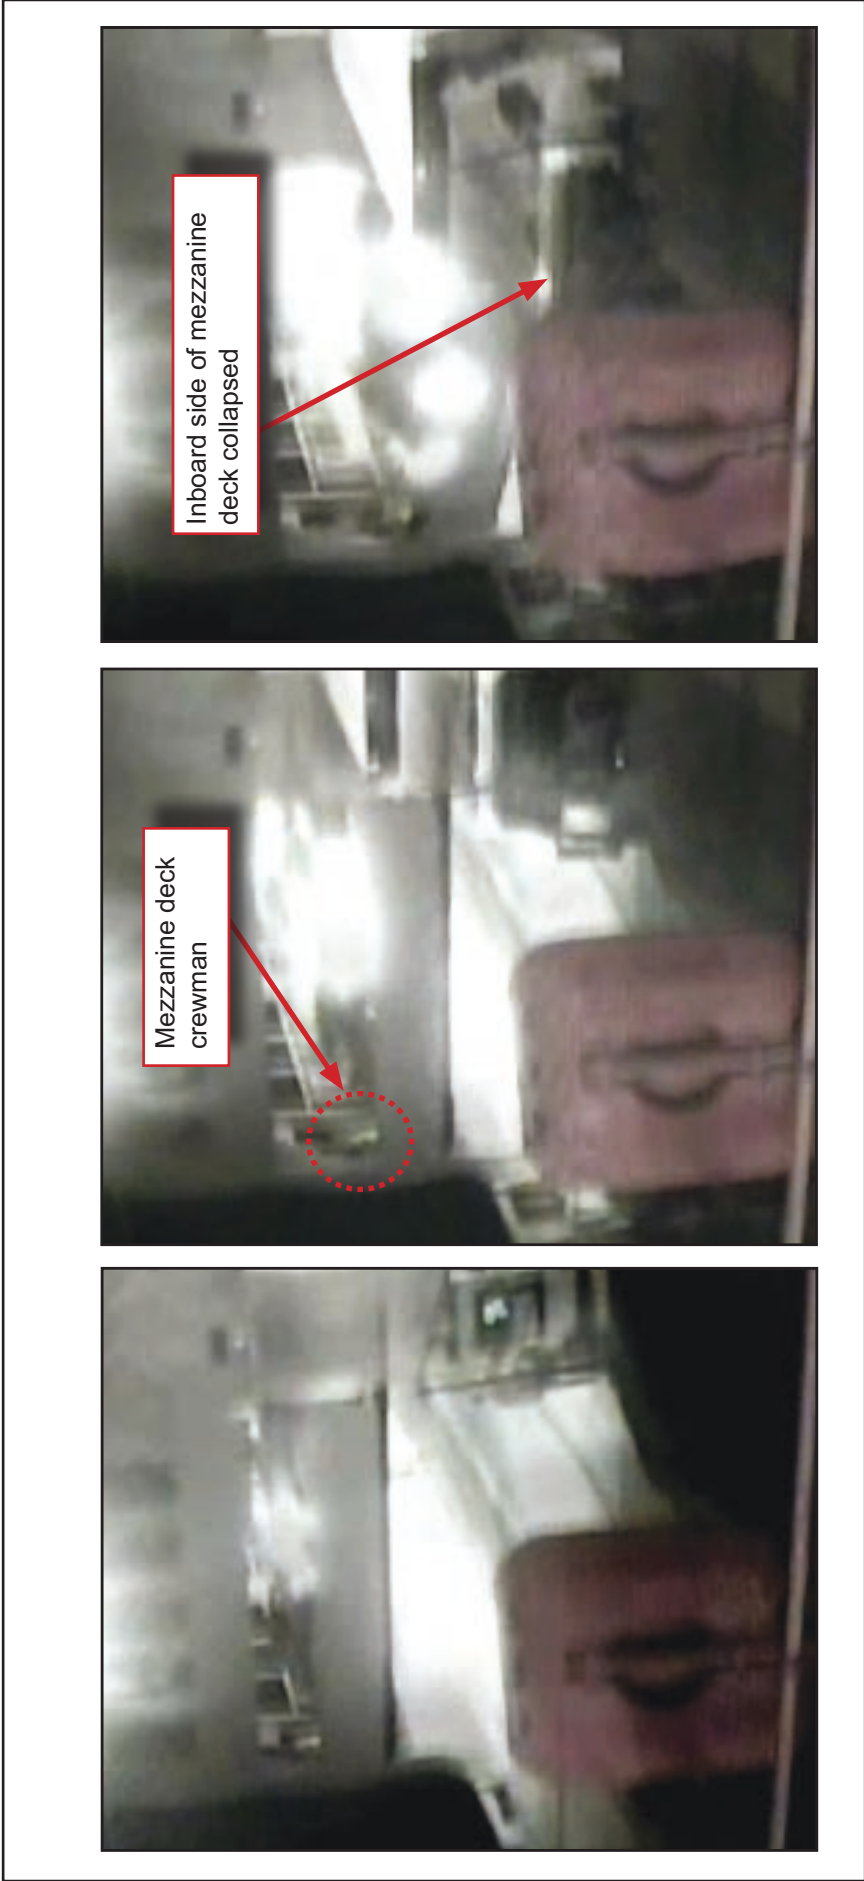
**Figure 4:** Closed-circuit television footage of the mezzanine deck collapse

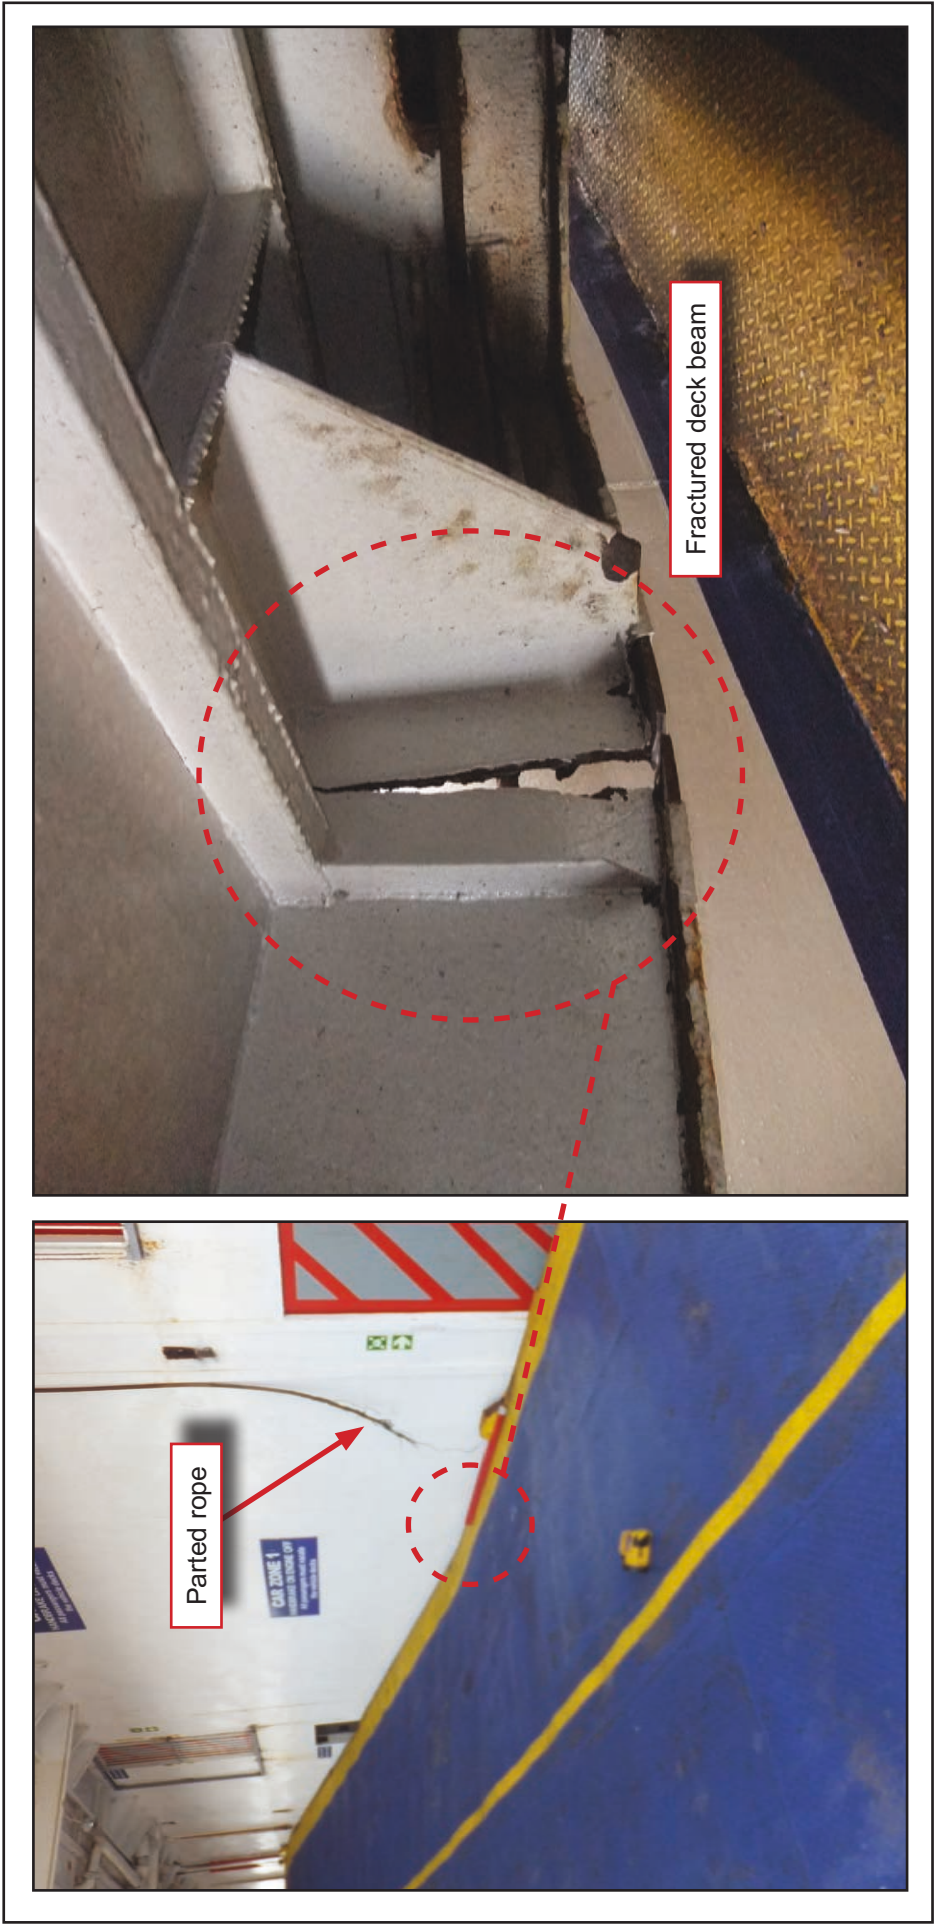
Figure 13: Parted inboard ramping rope and fractured deck beam

The morning after the accident, an MAIB inspector, two Maritime and Coastguard Agency (MCA) surveyors and Wightlink staff inspected the collapsed mezzanine deck. It was immediately apparent that the deck's inboard steel wire ramping rope had parted. It was also apparent that the main inboard longitudinal deck beam had fractured and failed (**Figure 13**).

grease; some showed signs of corrosion and wire strand damage (**Figure 15**). The deck beam fracture appeared to have started at its bottom plate and propagated up to the deck's top plate through a vertical weld seam. The quality of the weld appeared to be poor.

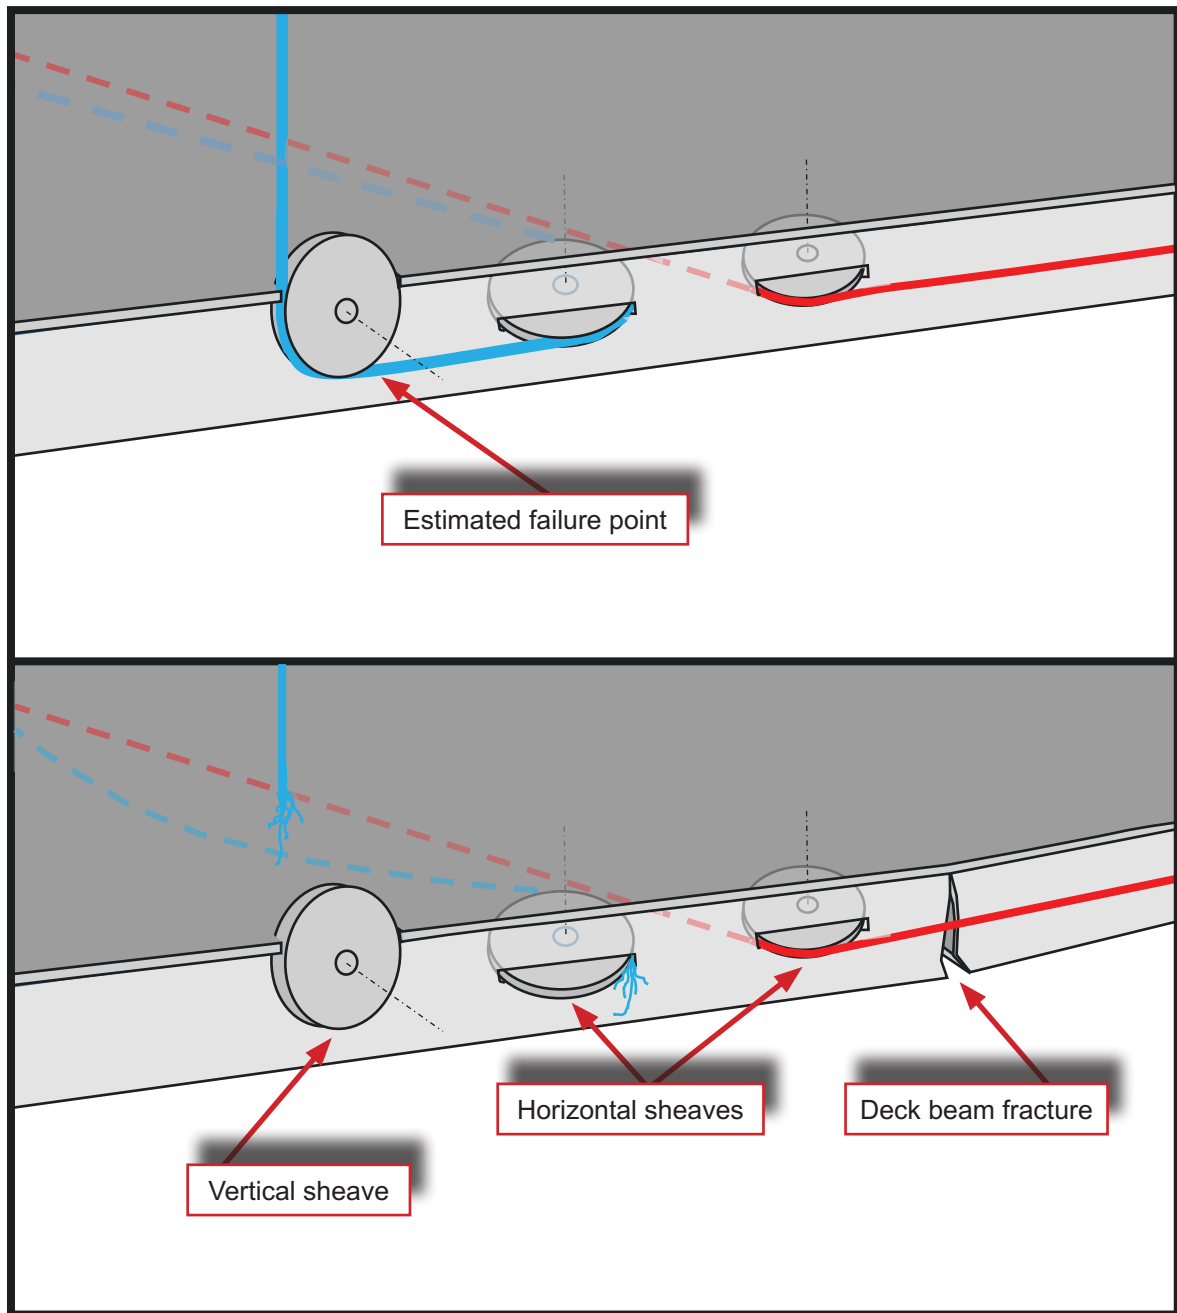
**Figure 14:** Locations of the ramping rope failure point and the deck beam fracture

The inboard ramping rope was found to have parted 2.45m from the deckhead. The failure point coincided with the location of the deck's inboard steel wire sheaves (**Figure 14**). The longitudinal deck beam fracture was approximately 18.5m from the mezzanine deck's inner (hinged) edge, just aft of the stowing rope's horizontal sheave.

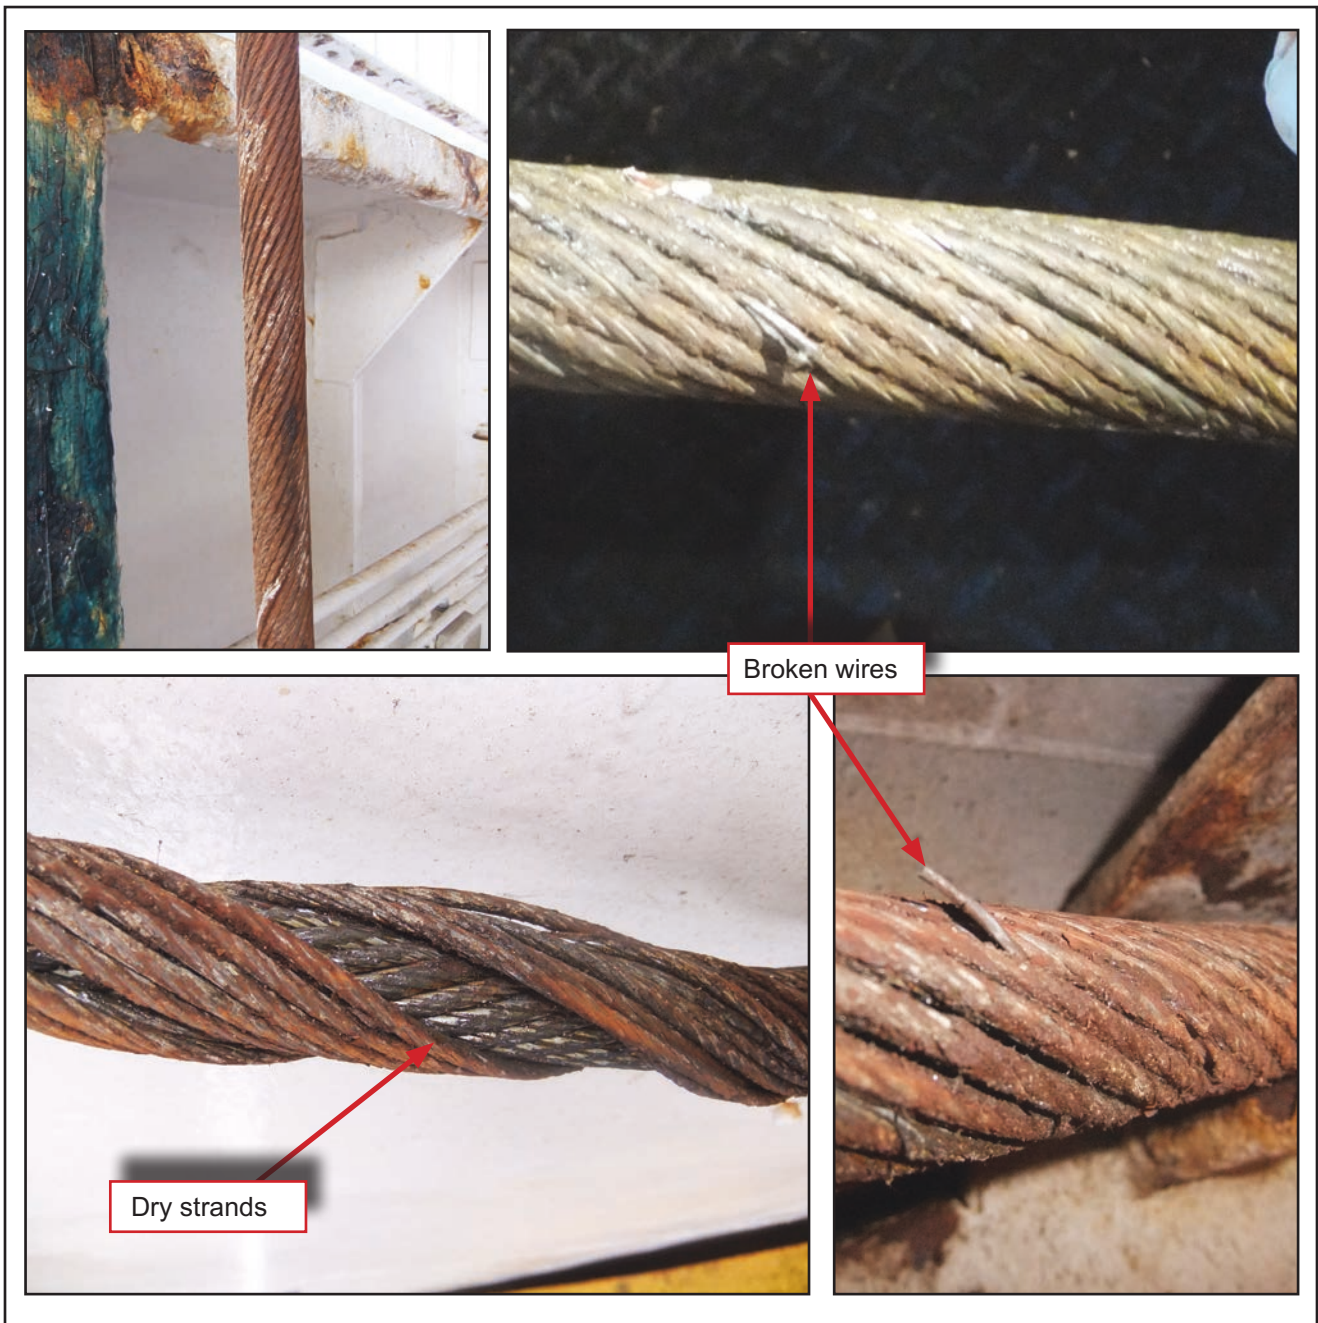
**Figure 15:** Condition of *St Helen's* mezzanine deck steel wire lifting ropes

A non-intrusive visual inspection of the other mezzanine decks and their lifting ropes was undertaken and the operation of the starboard aft deck was demonstrated by the ship's crew. Externally, the steel wire ropes were found to be dry and devoid of

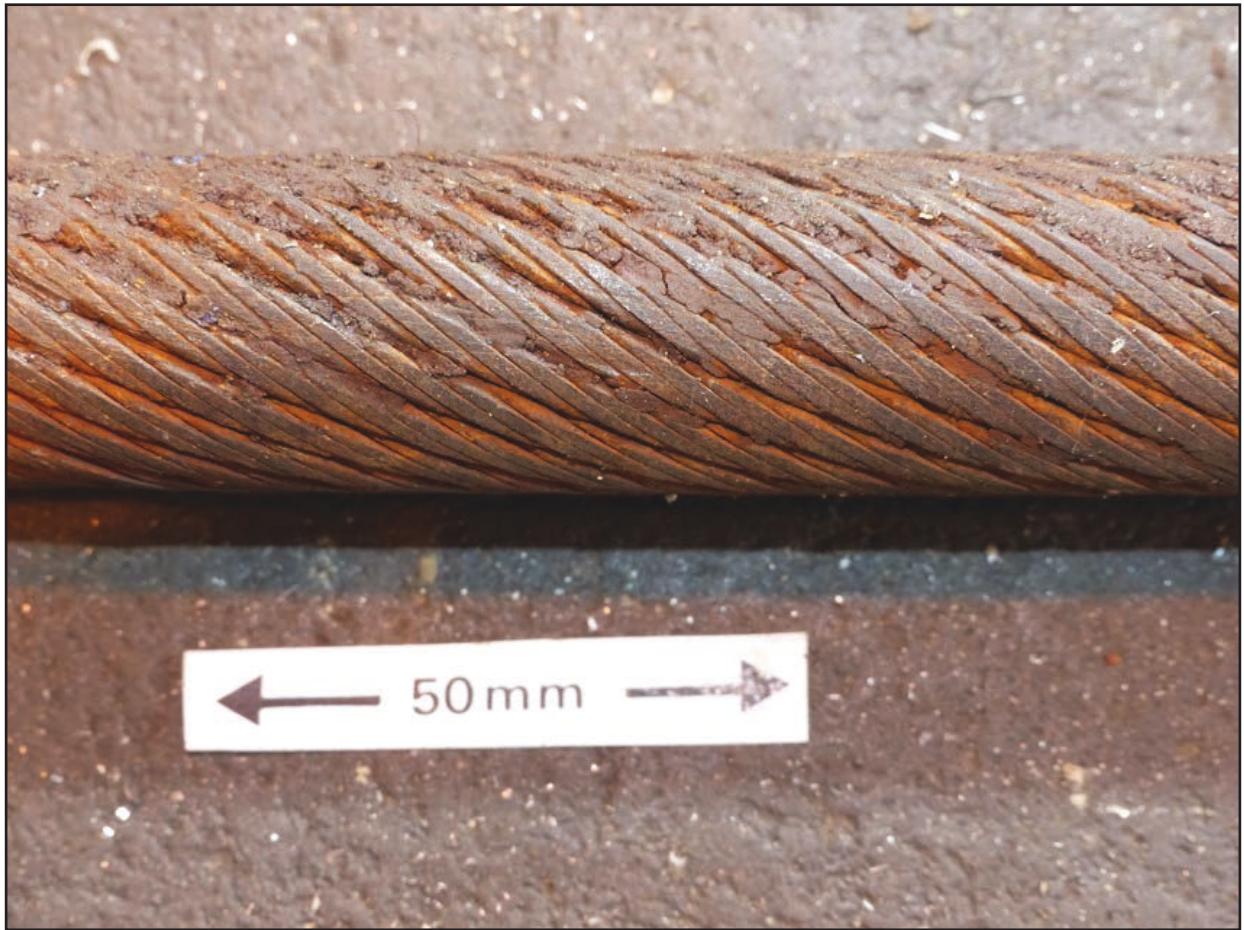
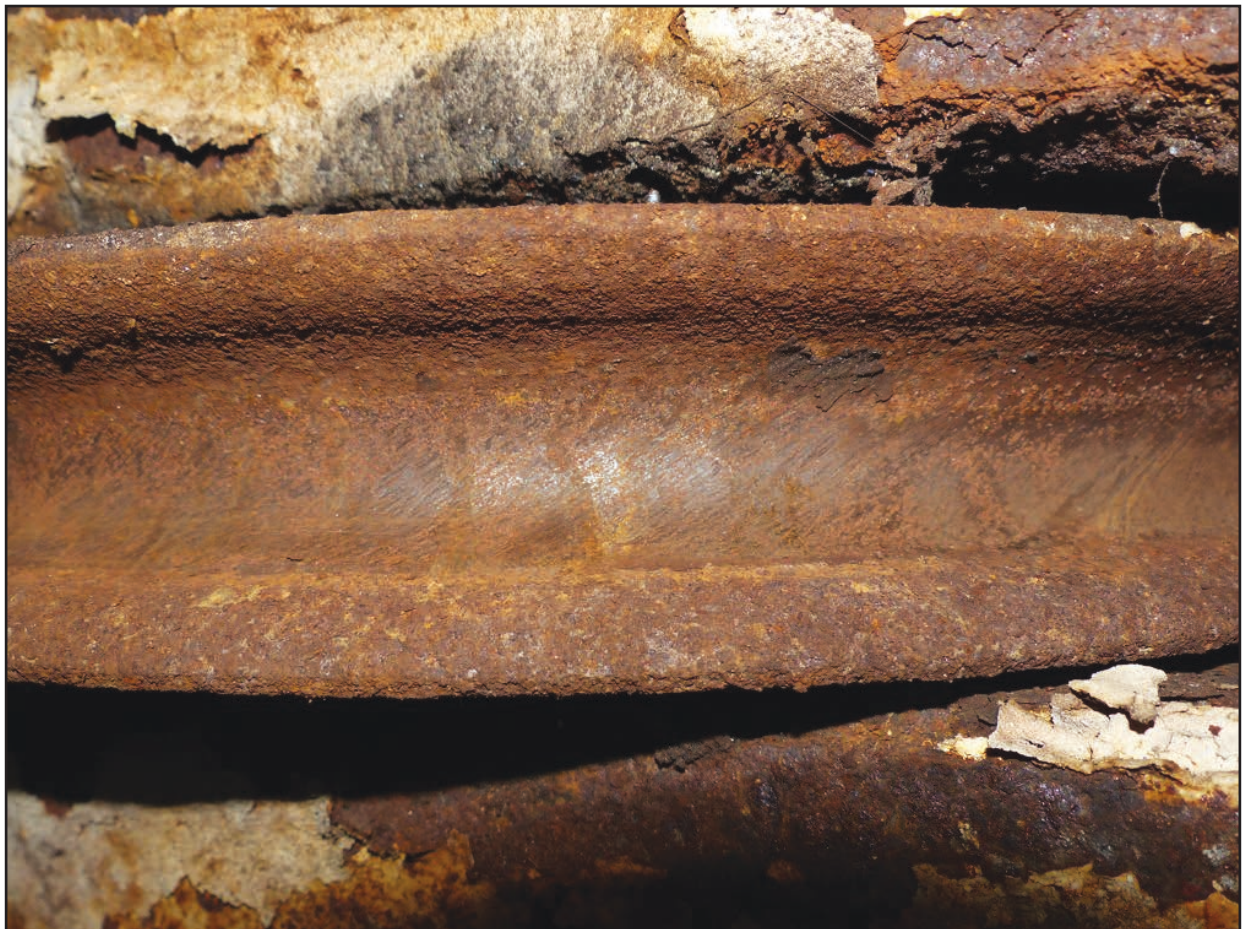
**Figure 16:** Photographs from the TTH report

TTH found that the outer strands of both inboard and outboard steel wire ropes were dry and had suffered mechanical wear (**Figure 16**). TTH also identified that there was little penetration of lubrication to the internal strands of the ropes.

TTH attributed the external wear to abrasion of the crown wires in the outer strands of the rope resulting from rubbing contact, under pressure with the grooves of the sheaves. The internal wear was caused by friction between the rope's individual wire strands. Referring to the failed rope, the report stated:

*Our detailed examination concludes that the dominant factor at the break site appeared to be overload due to excessive mechanical wear which in turn resulted from lack of service lubrication. Corrosion and fatigue are secondary contributing factors which are also attributed to the lack of lubrication.*

The report also identified that the wire rope sheave grooves had suffered wear (**Figure 16**). The ramping wire's vertical sheave was deformed, and off centred wear was found on its horizontal sheave, which was indicative of an incorrect fleet angle<sup>5</sup>. Both sheaves showed material wastage through corrosion and the absence of lubrication.

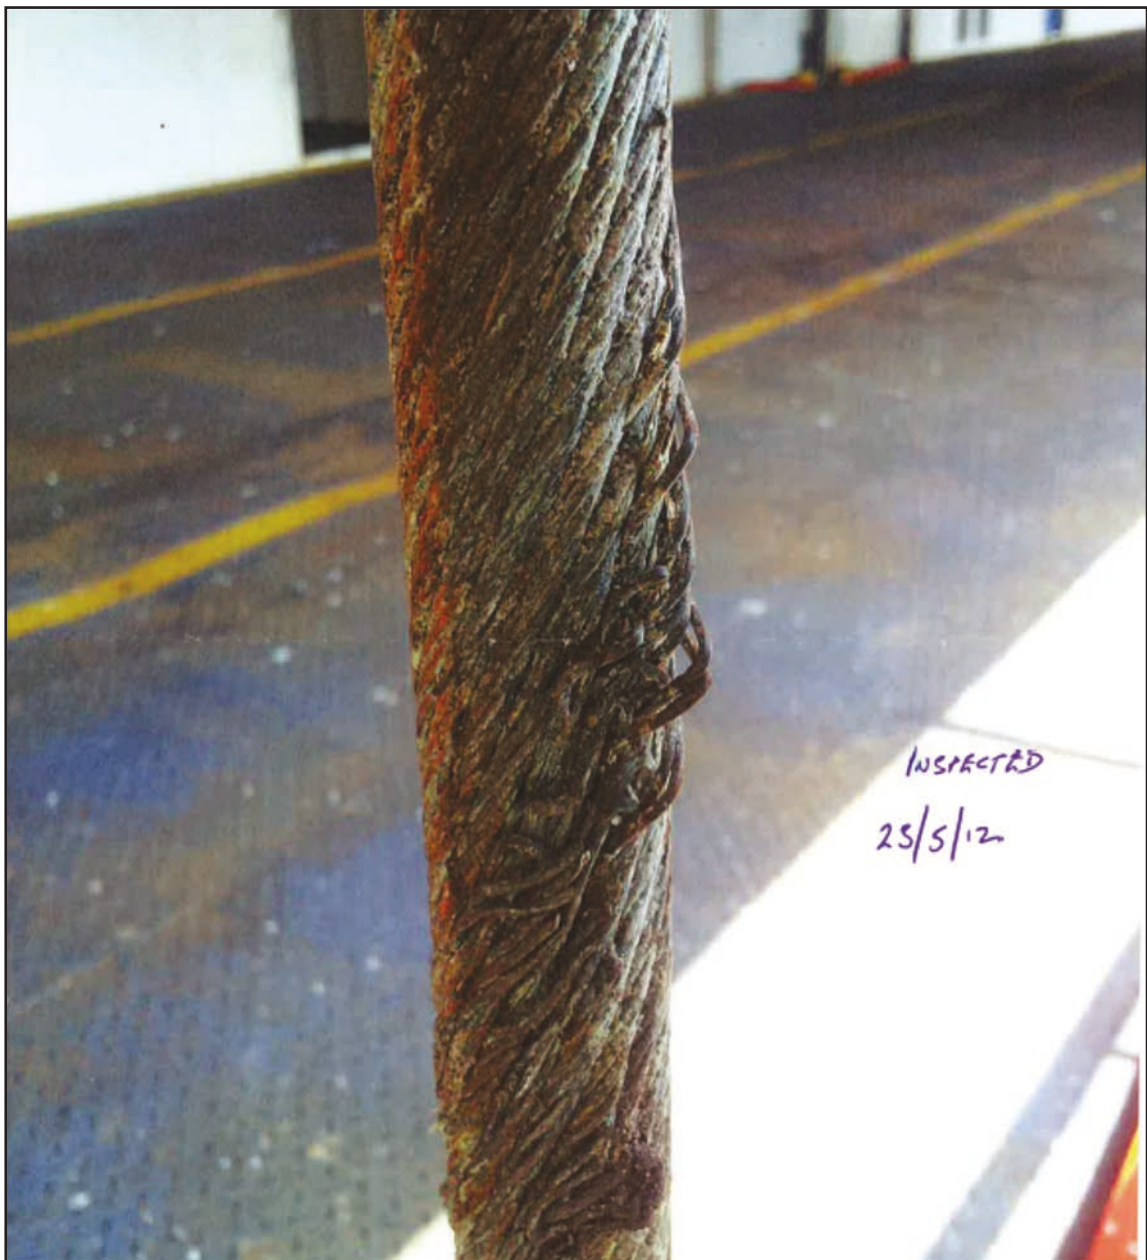
**Figure 18:** Photograph taken of a damaged mezzanine deck lifting rope by crew on board *St Helen* following an inspection carried out on 23 May 2012

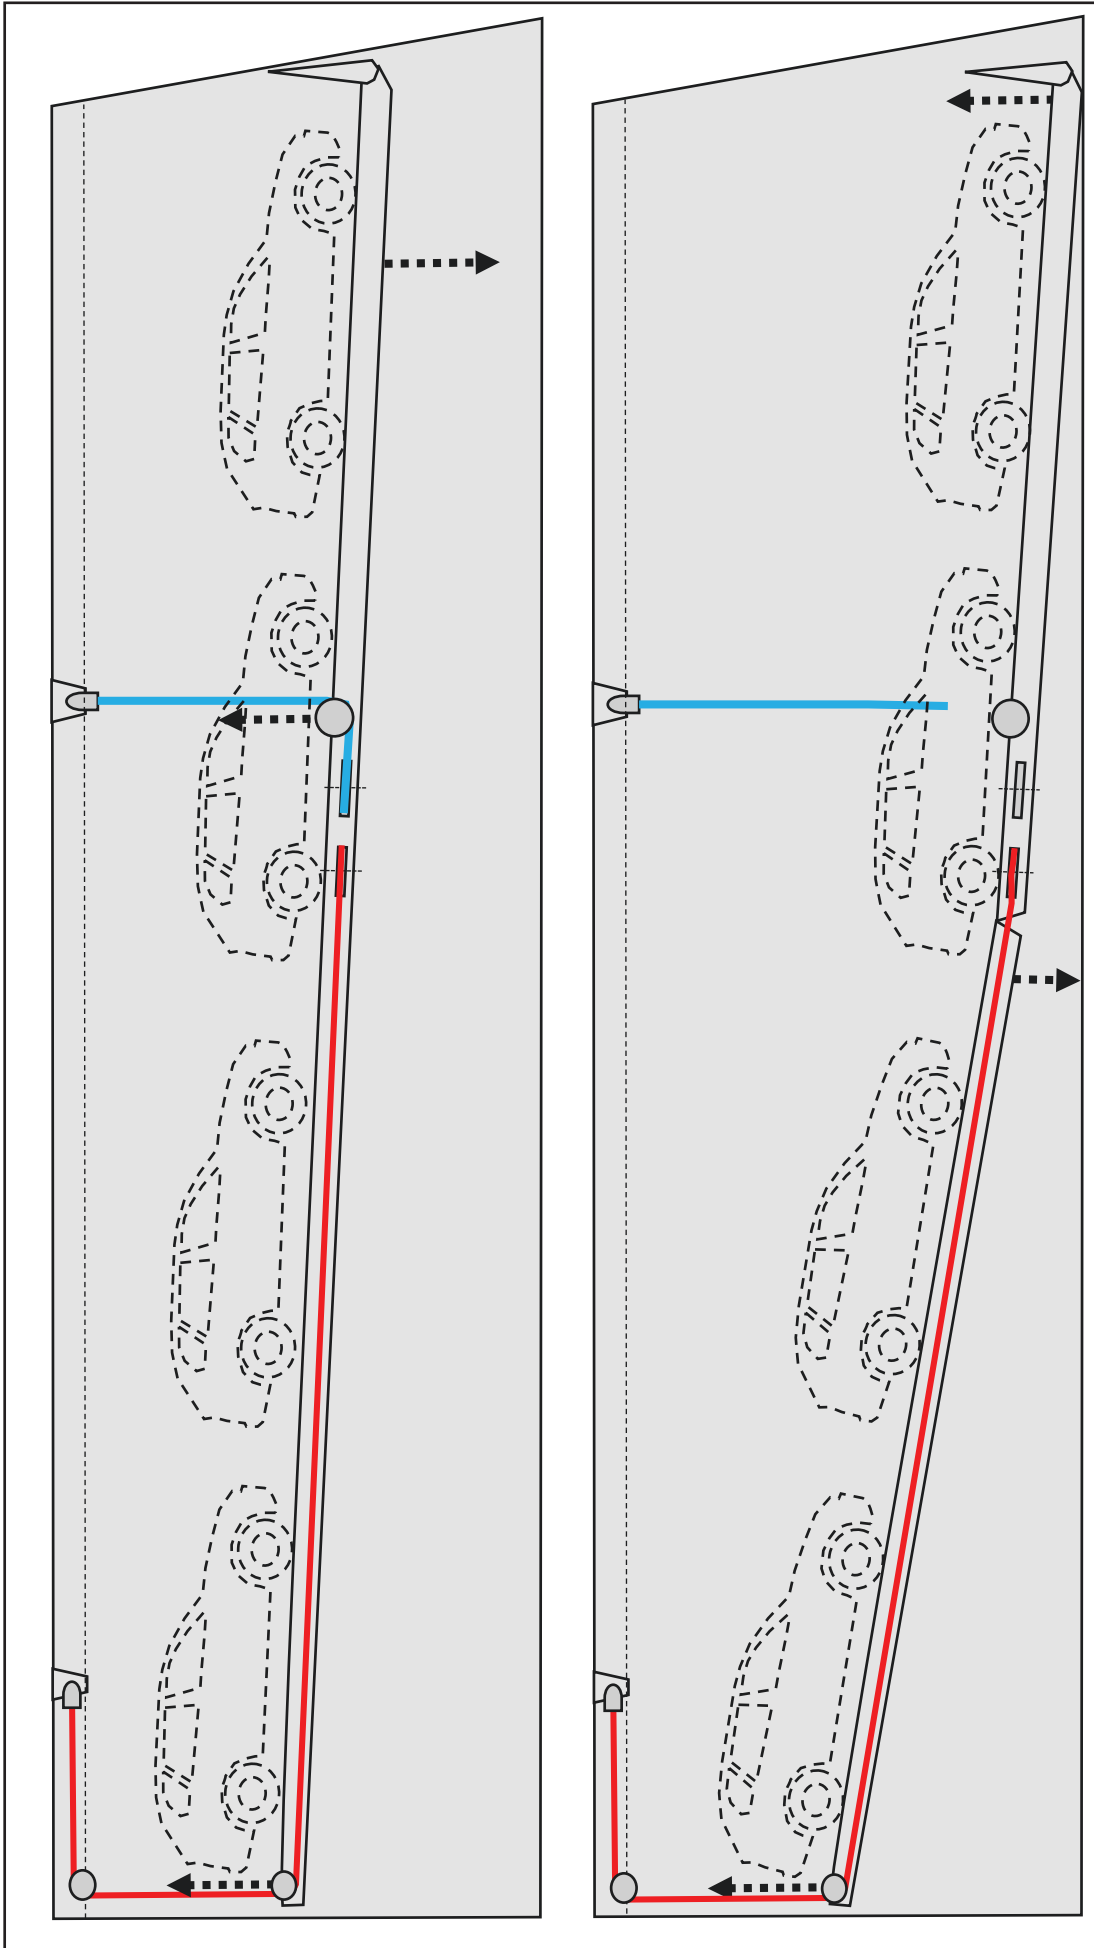
**Figure 19:** Change in the forces acting on the mezzanine deck's longitudinal beams after the wire rope parted
