AAIB Bulletin

8/2015

Published 13 August 2015

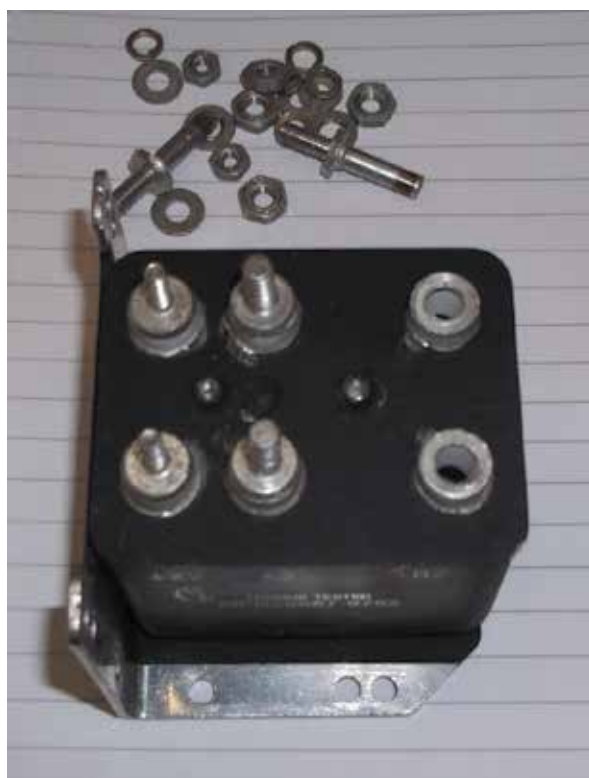
An examination of the circuit diagrams and the list of system losses indicated that the fault lay with the R1 or R326 relay. Power-off continuity checks were carried out across the two pairs of terminals on the R1 relay, but these were inconsistent and therefore inconclusive. The R1 relay was removed to aid further examination, but its removal was somewhat difficult as the terminals were loose and tending to rotate rather than remain stationary when an undoing torque was applied to the nuts. The outer collars had to be gripped with pliers in order to remove the nuts. It was difficult to carry out this task in the confined area at the bottom of the P6 bay in which the relay is located. It was also observed that the relatively large and stiff 'A' gauge cables and terminations were rigid, tightly tied within their wiring harness and did not naturally align with the terminals when the nuts were removed. When examined, the relay appeared to contain a loose object which rattled within the casing. Closer inspection of the relay terminals B1 and B2 found them to be loose and no longer fixed to their insulated mounting in the relay, to the extent that they fell out when the relay was inverted. The A1 and A2 terminals were also loose within their insulated collar, but remained in place. Figure 1 shows the R1 relay after removal.

R1 relay with detached B1 and B2 terminals

The reproduction of the electrical power distribution system symptoms after the incident and the rectification by replacement of the R1 relay, confirmed the failure of the R1 relay as being causal. In order to lose power to the battery bus there needs to be a loss of continuity between the A or B terminals; for this to happen one or both of the terminal post must be permanently misaligned or become 'out of reach' of the contactor plate. The continuity checks in situ, with power off, (ie the relay in a de-energised condition) were inconclusive, probably due to the terminals being loose.

Despite the exact material failure mode, the loss of the battery bus was due to the loss of electrical continuity across the B1 and B2 terminals, as this is the normal position of the Battery Bus Auto (R1) contacts for the Battery Bus to receive 28V DC from TR-3 before the relay failure. In order for this to happen a misalignment or small movement away from the contactor blade must have taken place. The length of the terminal within the relay would effectively amplify any movement at the cable connection end of the terminal, thus increasing the risk of the loss of contact. The cause of the movement cannot be determined beyond doubt. However, an over-torque on a terminal and the presence of a constant side load or tension from the stiff wiring harness is the most likely scenario to have taken place on one or more of the terminals. It is possible that excessive torque was applied to the terminals at installation or during subsequent maintenance, resulting in a weakening of the terminal insulator soldered joint.

A replacement relay was fitted and further aircraft power supply tests were carried out, during which all aircraft systems functioned normally. In order to verify the diagnosis, the aircraft ground power was left on the aircraft for approximately one hour, with no emergent faults. The R326 relay was found not to be involved and operated correctly.

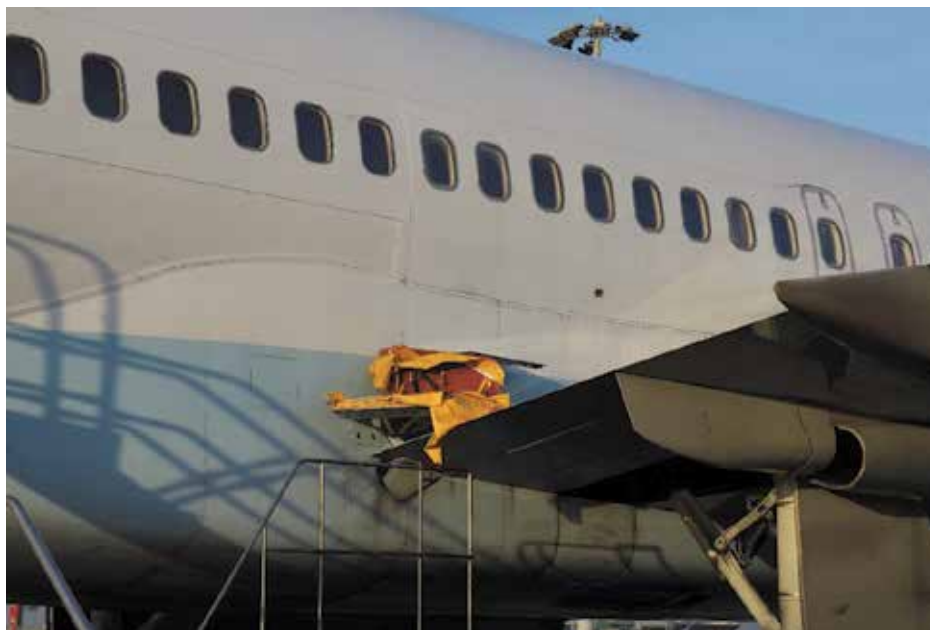
On examination it was evident that the right over-wing slide carrier had deployed and had rotated outwards. The carrier bay panel was open, attached by its hinges, and resting on the carrier. The slide pack cover was open and the slide was missing. The outer rigid sideboard of the pack had detached and was on the hardstanding beneath the aircraft. The carrier outward travel stop hook had broken from its mounting tube and detached. The carrier had over-rotated causing damage to the fuselage wing root upper fairing, forcing the actuator rod to extend and bend and cause damage to the carrier pivot forging. The slide pack lacing pin had withdrawn from the slide cover and was hanging loose attached to the aircraft by its pip-pin and lanyard. Figure 4 and Figure 5 show the slide carrier as found.

The slide carrier as it was found after landing

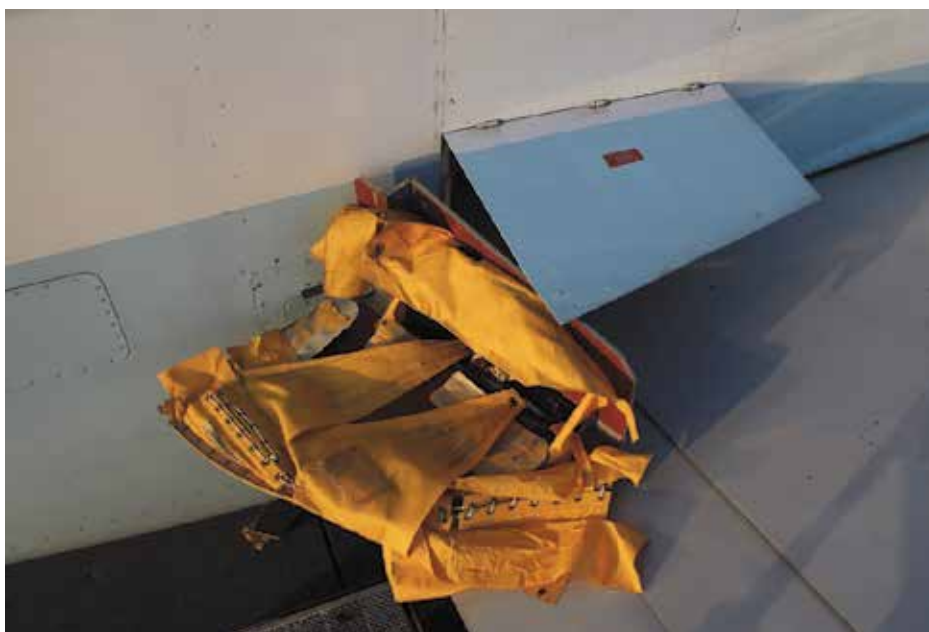
Figure 5

A close-up of the slide carrier after landing

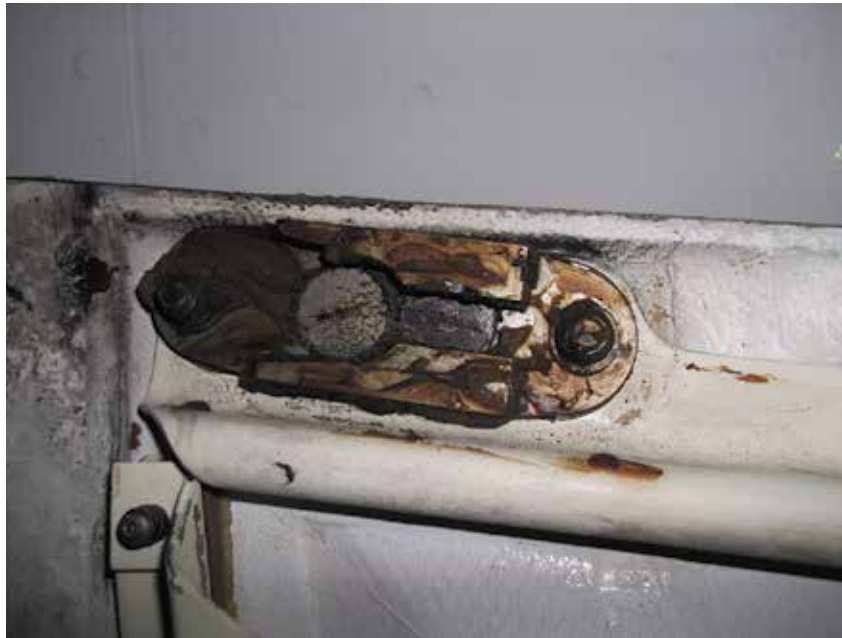
The carrier locking device was retracted into its release position and was undamaged as were the panel latch rod tappets and slots. The forward and aft slots and tappets were covered in a protective layer of grease. The aft slot and tappet grease layer exhibited marks indicating where the tappet had been located. One of the marks was within the forward end

of the slot, the locked position, and the other more pronounced mark was at the opening to the slot indicating movement of the panel during tappet and slide disengagement. The forward tappet and slot had the only marks in the grease on top of the slot edges and indicated that the tappet had not been engaged within the slot in any position as shown in Figure 6 and Figure 7.

The slide panel aft latch tappet imprints within the slot

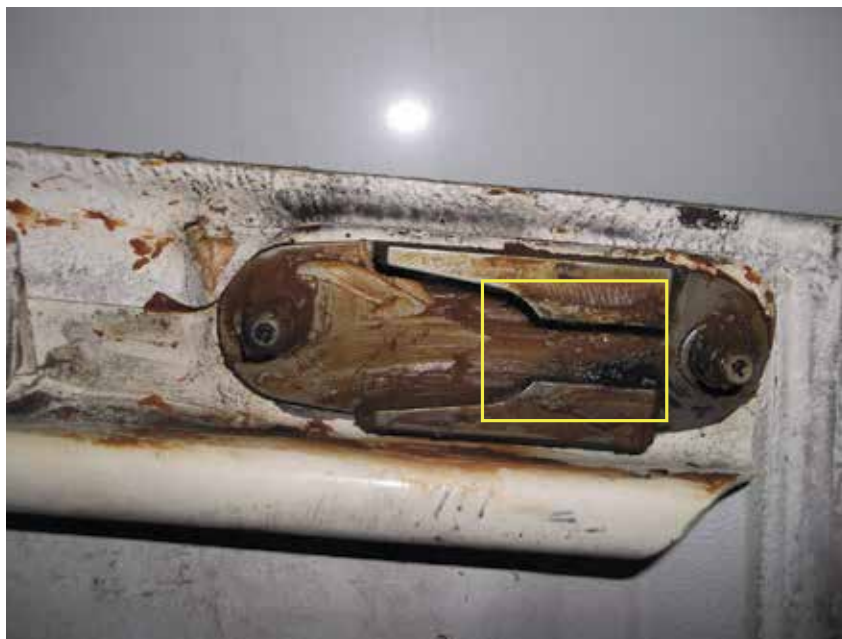
Figure 7

Slide panel forward latch slot with the tappet imprint in the grease on the slot outer face

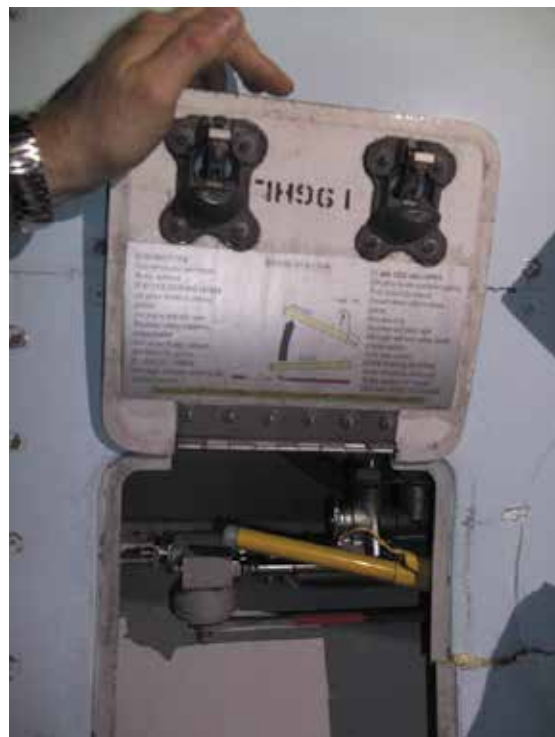
Figure 8

Right slide release cranked handle in the up position as found after the incident

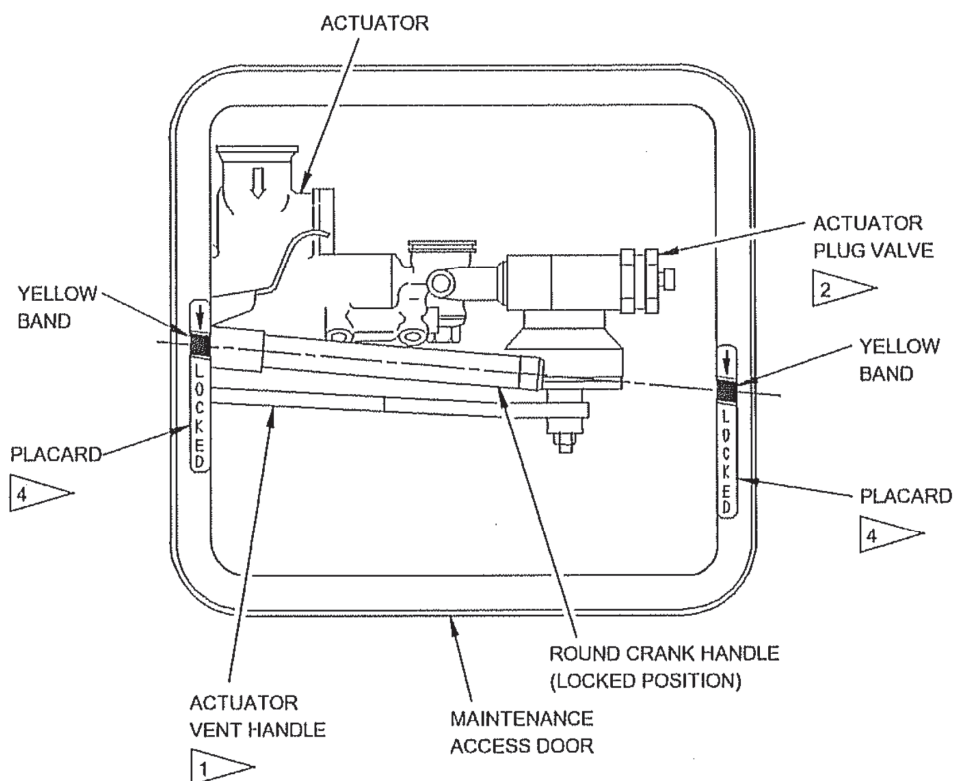
Figure 11

Several operators had previously reported in-flight over-wing uninflated escape slide losses. The cause was identified as the slide compartment panel not being fully locked and secured, even though appearing to be so, after access for maintenance. Accordingly the manufacturer issued Service Bulletin (SB) 757-25-0298 which was subsequently mandated by a FAA Airworthiness Directive (AD) 2012-01-09. The SB instructed operators to fit modified parts to the panel latching mechanism to provide more positive locking. It also introduced placards for better visual indication of the correct position of the crank handle (Figure 11). The AD required the actions of the SB to be completed by end of February 2017. SB 757-25-0298 was not embodied on G-JMAB at the time of the incident.

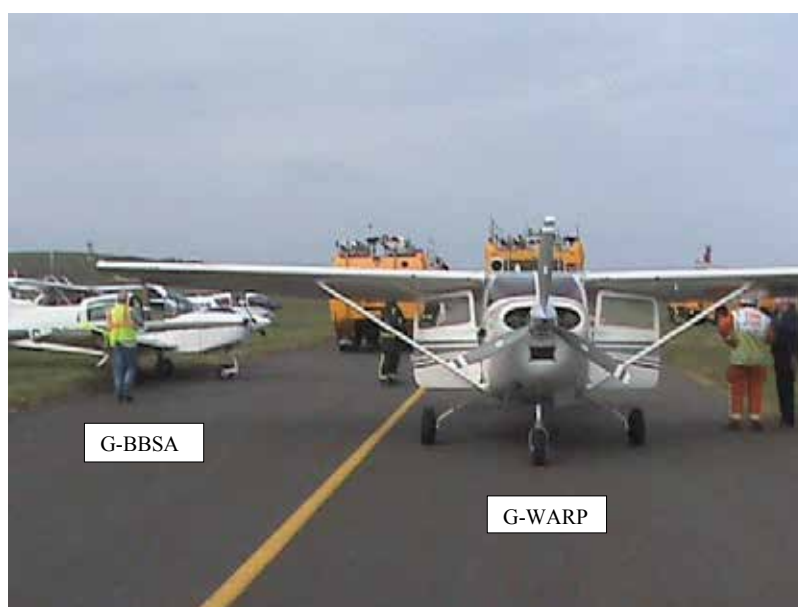
Figure 1

Just prior to the accident, the pilot of G-BBSA pulled the aircraft forward until the nosewheel was on the taxiway and the mainwheels were on the edge of the taxiway, Figure 1. He then started the engine and waited for an opportunity to contact the Tower on the radio to request taxi and departure clearance. He heard an aircraft being given taxi and departure clearance and watched G-WARP as it taxied along Taxiway D, which had been reclassified as an apron, towards him. Initially he thought the right wing on G-WARP would clear his aircraft, but at the last moment realised that it would hit his propeller and therefore attempted to shut the engine down. However the outer section of the wing struck his propeller while the engine was rotating at approximately 1,000 rpm.

Position of G-BBSA and G-WARP after the collision
(Photograph courtesy Ronaldsway Airport)
