Report on the investigation of  
the collapse of a mezzanine deck on board  
the roll-on roll-off passenger ferry  
***St Helen***

Fishbourne Ferry Terminal, Isle of Wight  
on 18 July 2014

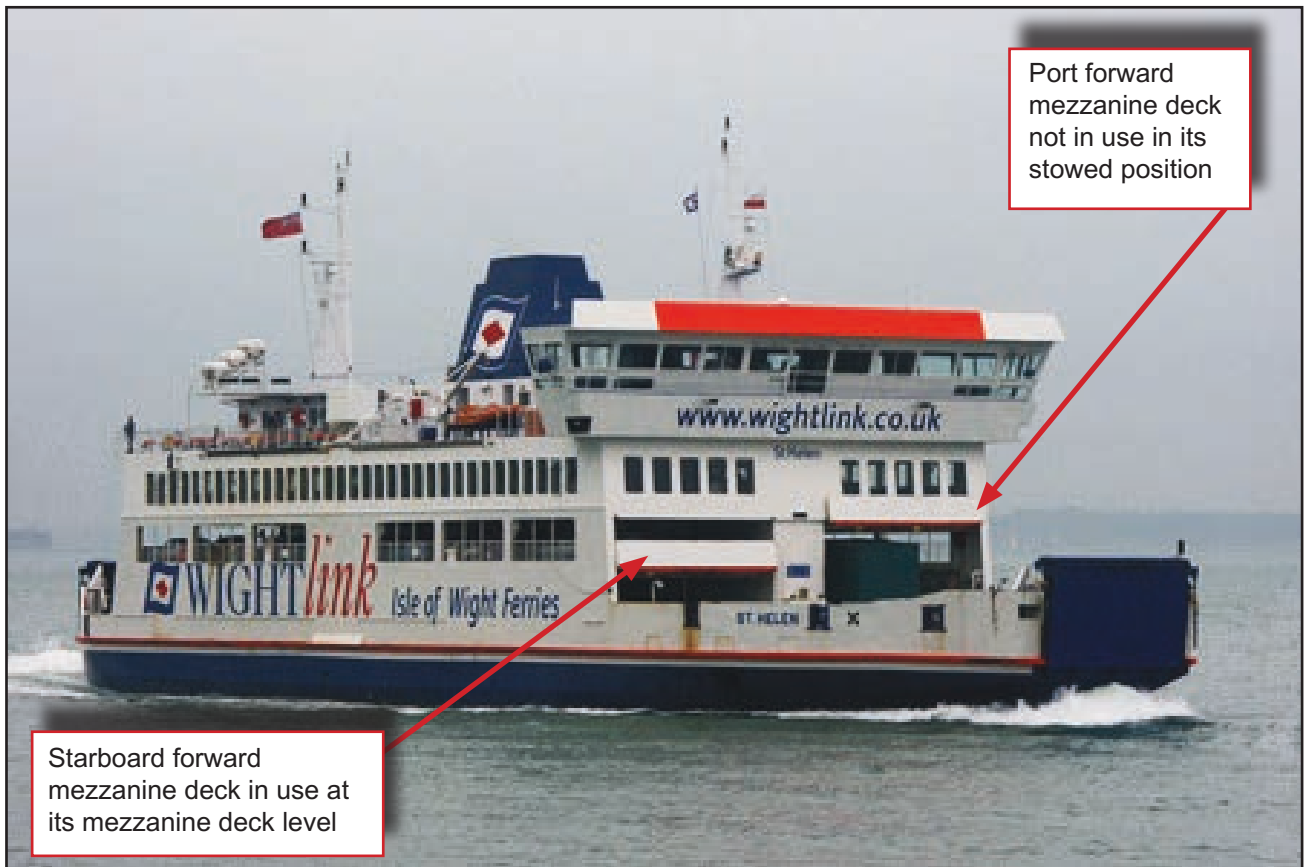
**Figure 2:** *St Helen* on passage in the Solent with its starboard mezzanine decks in use and its port mezzanine decks in their stowed position

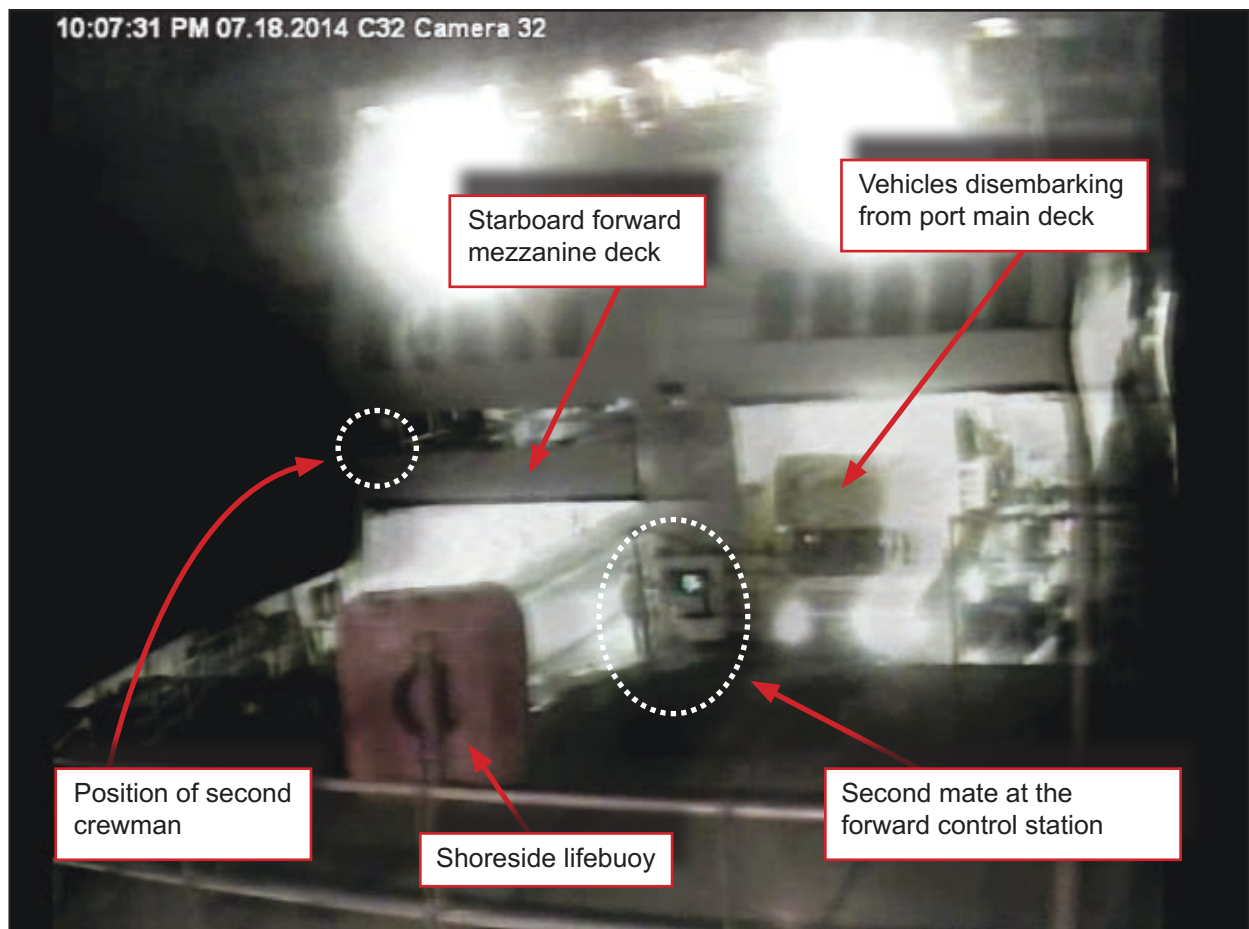
**Figure 3:** Second mate at the forward mezzanine deck control station while vehicles are being driven off the port main deck

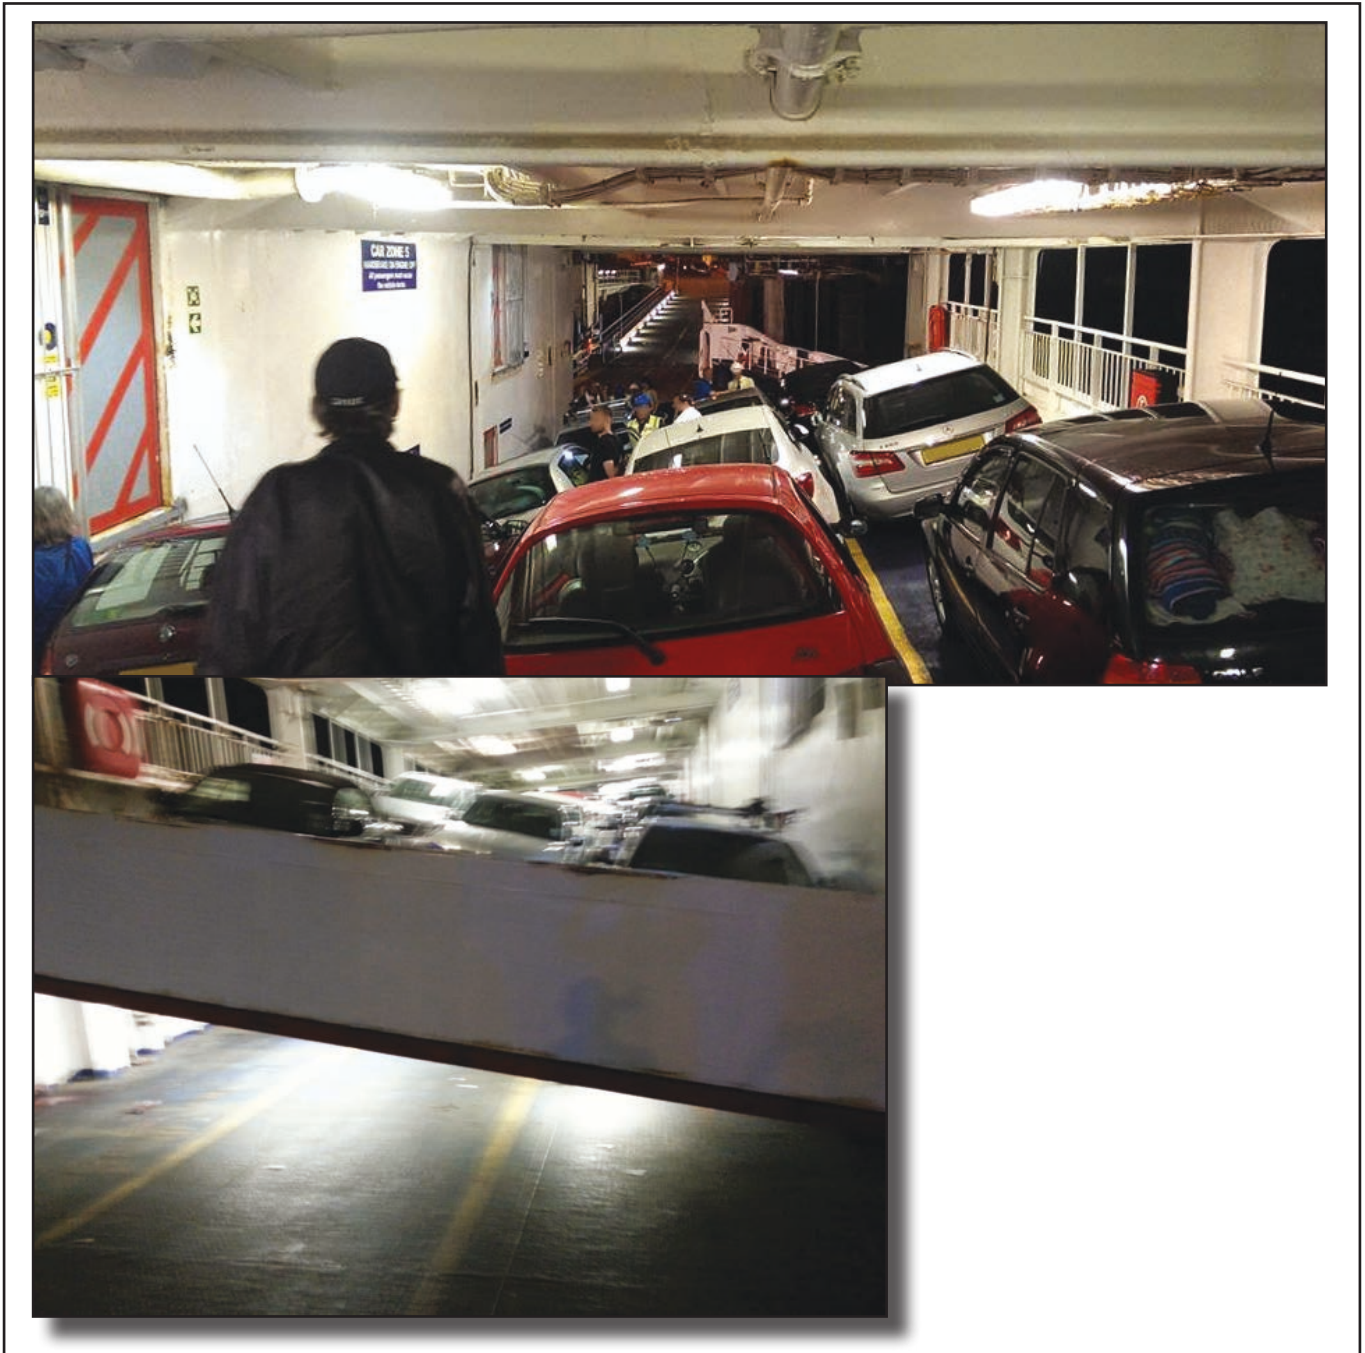
**Figure 5:** Evacuation of the passengers from the mezzanine deck to the passenger lounge

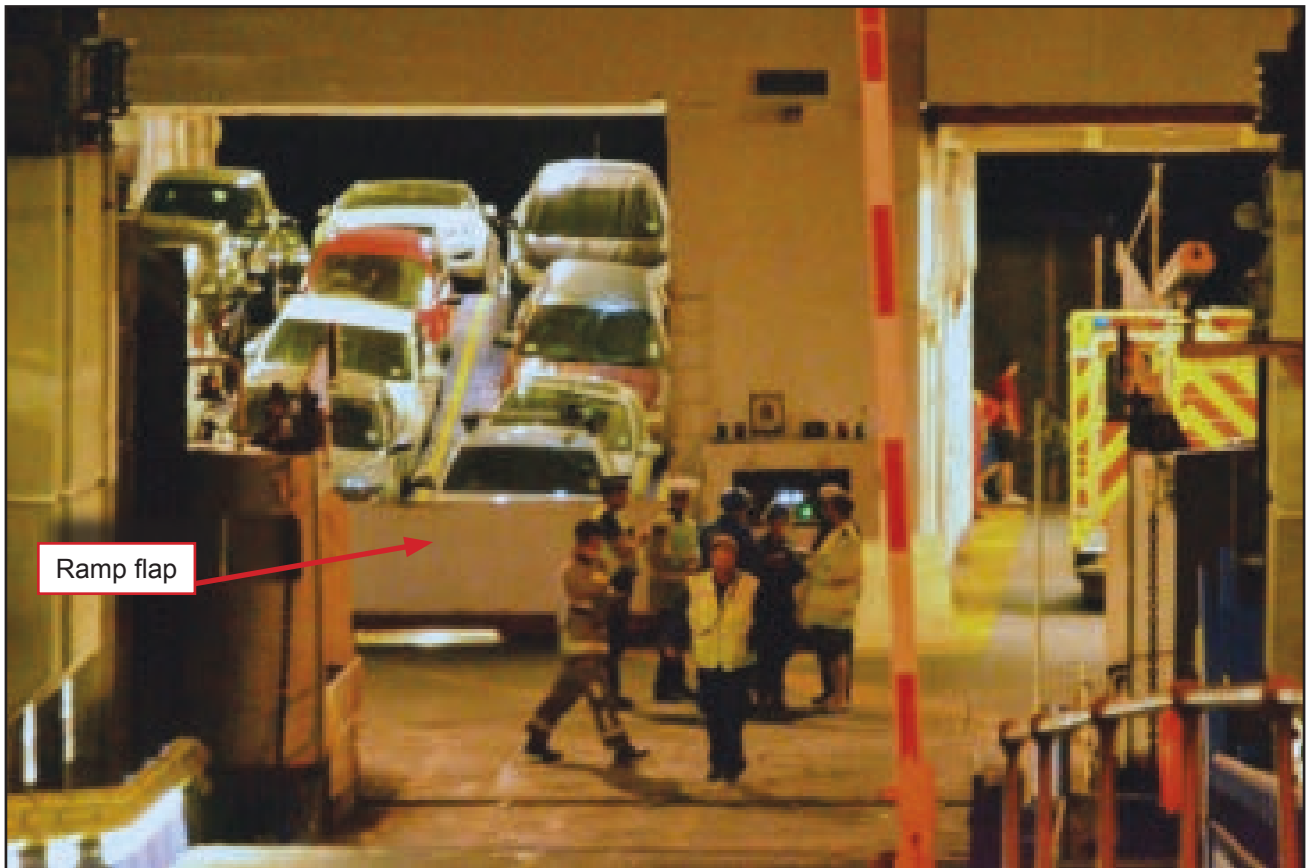
When the forward mezzanine deck was clear of passengers, the crew lowered its forward outboard corner to the main deck (**Figure 6**). Once the forward edge of the deck was level on the main deck, the crew were unable to drive the vehicles off the mezzanine deck because they could not lower its end flap. The crew then lowered the starboard aft mezzanine deck and, with the assistance of the police, the passenger vehicles were reversed onto the main deck.

**Figure 6:** Outboard side of mezzanine deck lowered to main deck level

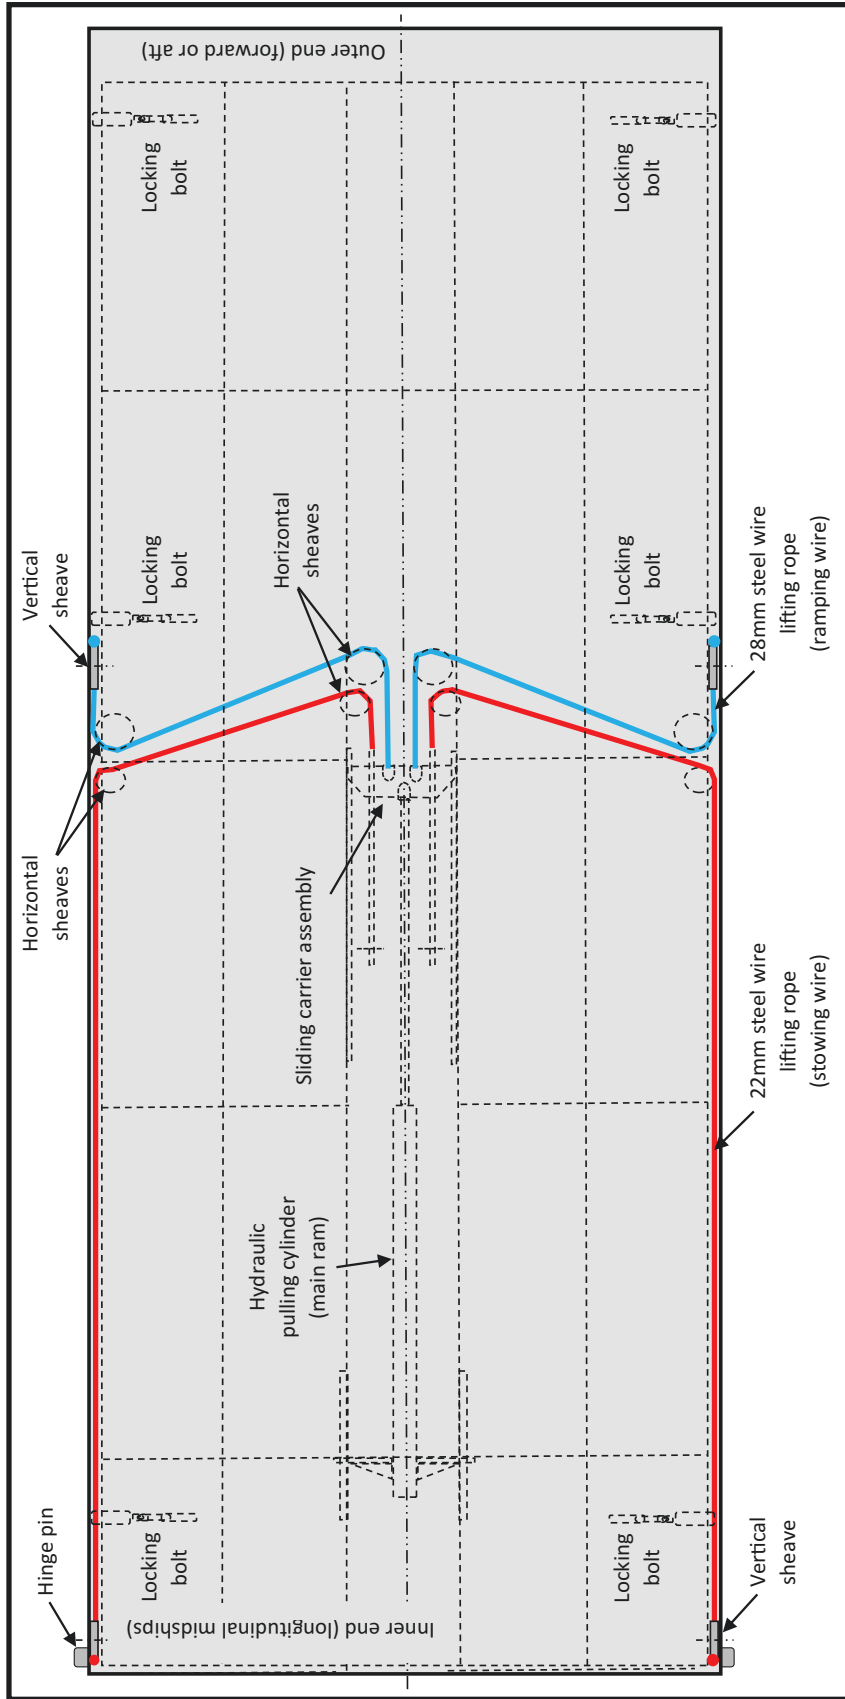
**Figure 7: Mezzanine deck raising and lowering arrangements**

The decks were raised and lowered by a hoisting arrangement that comprised a direct double-acting hydraulic 'pulling' cylinder (main ram), a sliding carrier assembly and four galvanised anti-twist steel wire lifting ropes (**Figure 7**). The main ram and sliding carrier assembly were mounted within the mezzanine deck structure underneath the top plates. The mezzanine decks had three operational positions (**Figure 8**). These were:

The lifting ropes were anchored at one end to the ship's superstructure at deckhead level. The other end of each rope was rove through a series of sheaves located at the edges and underneath the mezzanine decks, and connected to the sliding carrier assembly. The sliding carrier assembly was moved by the main ram. To raise the mezzanine deck, the main ram pulled in on the sliding carrier assembly; this caused the deck sheaves to roll up the anchored lifting ropes (**Figure 10**). To lower the deck, the hydraulic pressure in the system was released and the weight of the deck forced the sheaves to roll down the lifting ropes. The mezzanine decks on the newer *Saint* Class vessels operated in a similar way, but they had a double lifting rope arrangement that provided 100% redundancy should one rope fail.

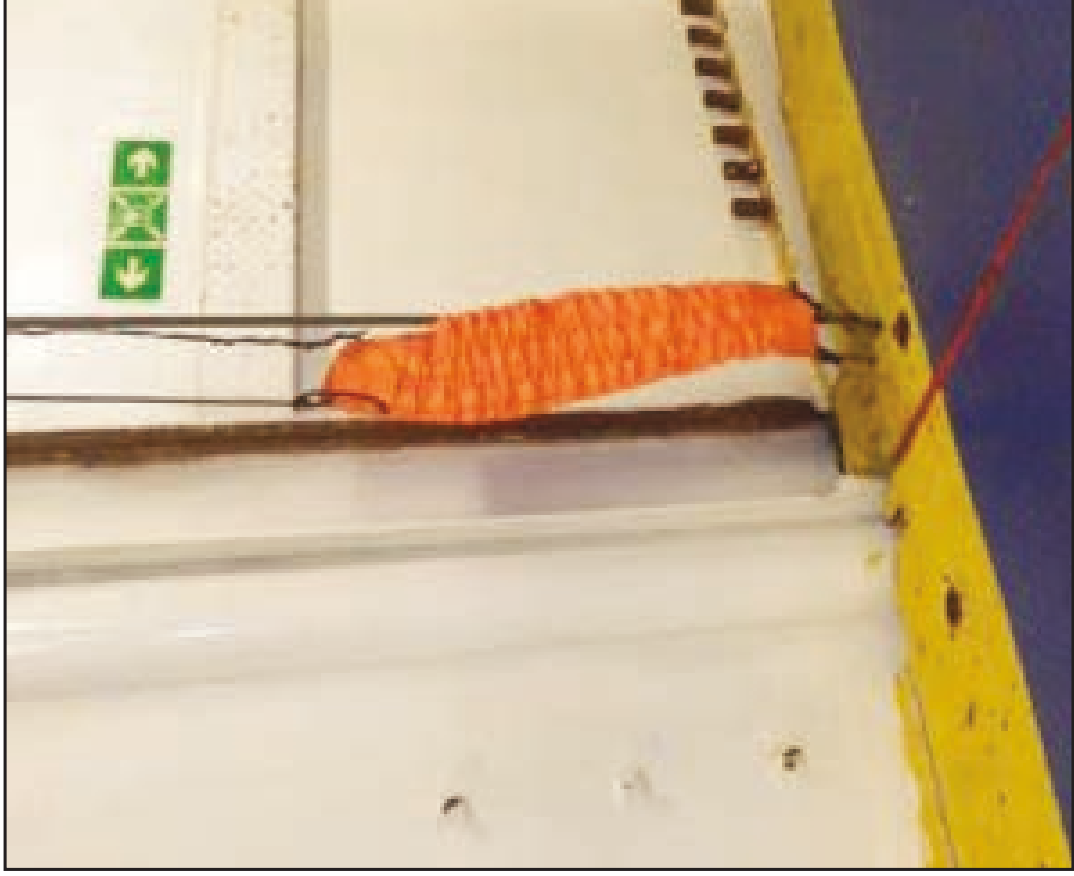
Elasticated lifting rope grease guard on board St Claire
