AAIB Bulletin

8/2015

Published 13 August 2015

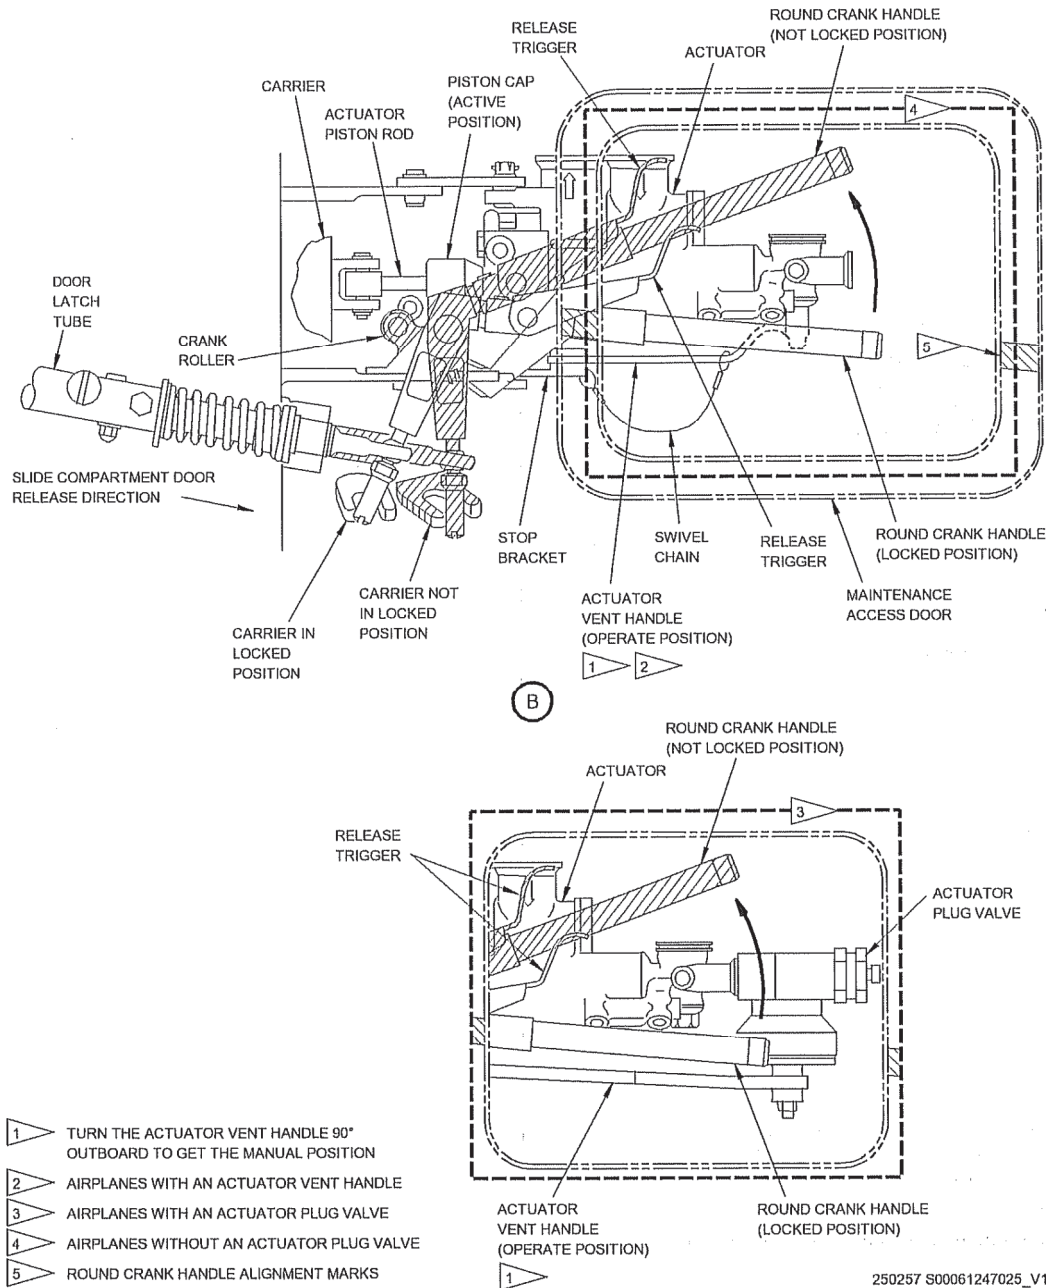
The actuator (Figure 2) is fitted with a vent lever, coloured red, which when rotated outwards to the 'manual' position allows the actuator piston to be moved manually and prevents gas pressure acting on the actuator. When the vent lever is in the manual position its handle protrudes outside the fuselage and its access panel cannot be closed.

In addition to the vent lever there is also a yellow crank handle fitted alongside the actuator. It is normally in the down, just below horizontal, position. When it is moved upwards, to approximately 30° above the horizontal, it releases the slide door, by retracting the door latch tube, and withdraws the slide carrier restraint device. Its purpose is to replicate the unlocking actions of the actuator to allow maintenance and inspection of the slide and its carrier without having to operate the actuator using gas pressure. The crank handle has a secondary function whereby the lifting of a trigger assembly on the handle and rotating it back down engages a hook on the slide carrier with the door latch tube to lock the slide carrier in the deployed position. To enable maintenance staff to check for the correct orientation of the crank handle, yellow paint marks are specified on the doubler plate, known as the land, surrounding the access hole on the inside, which abuts against and supports the back of the access panel when it is closed. The marks align with the lever when it is correctly positioned with the slide carrier locked and the slide panel closed. Figure 2 shows the slide actuator and crank handle assembly.

Figure 2
 Slide carrier actuator assembly (left side shown)
 (Boeing Proprietary. Copyright © Boeing
 Reprinted with permission of The Boeing Company)

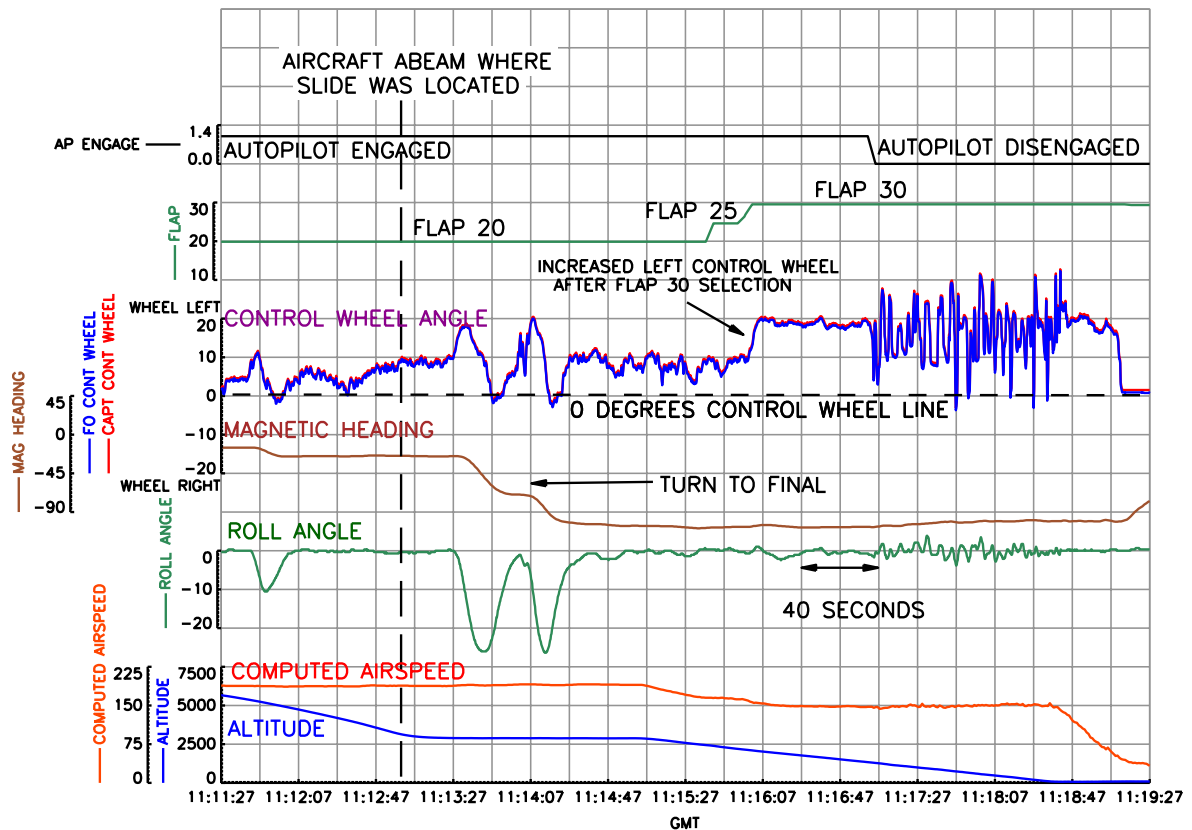
Figure 3

Flaps 30 was selected after the turn onto the final approach after which the control wheel input increased to an average of 20° to the left (see Figure 3). The autopilot was disconnected as the aircraft descended through 1,400 ft on the final approach.

G-JMAB FDR data during approach to Gatwick Airport
