An Explosive Decompression Accident

Four divers in a compression chamber system were suddenly decompressed from 9 atm to 1 atm. One of the divers was about to close the door between the chamber system and the trunk when the accident happened. He was shot out through the door and severely mutilated. The three others died on the spot. The autopsy results are described. The most conspicuous finding was large amounts of fat in the large arteries and veins and in the cardiac chambers, as well as intravascular fat in the organs, especially the liver. This fat can hardly have been embolic, but must have "dropped out" of the blood in situ. It is suggested that the boiling of the blood denatured the lipoprotein complexes, rendering the lipids insoluble.

On 5 November 1983, an accident resulting in the sudden decompression of four divers from a pressure of 9 atm to 1 atm occurred on board the Norwegian oil rig Byford Dolphin in the North Sea.

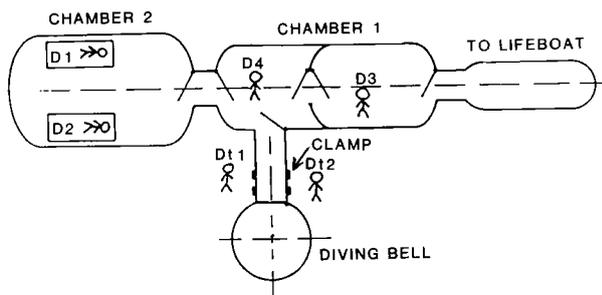
The situation just before this accident occurred was as follows (Fig. 1). Compression chambers 1 and 2 were connected via a trunk to a diving bell. This connection was sealed by a clamp operated by two tenders (Dt 1 and Dt 2), who themselves were experienced divers. A third chamber was in fact connected to this system, but was not involved. On this day, divers 1 (35 years old) and 2 (38 years old) were resting in chamber 2 at a pressure of 9 atm. The diving bell with divers 3 (29 years old) and 4 (34 years old) had just been winched up after a dive and joined to the trunk. Leaving their wet gear in the trunk, the divers had then crept through the trunk into chamber 1. The normal procedure would have been to (a) close the bell door, (b) slightly increase the bell pressure to seal this door tightly, (c) close the door between the trunk and chamber 1, (d) depressurize the trunk to 1 atm, and (e) open the clamp to separate the bell from the chamber system.

FIG. 1. Sketch of the compression system and the involved persons' position just before the accident occurred.

Operations a and b had been completed and diver 4 was about to carry out operation c when, for some inexplicable reason, one of the tenders opened the clamp. The result was a free communication between the chamber system with a pressure of 9 atm and the surroundings with a pressure of 1 atm. A tremendous blast shot from the chambers through the trunk, pushing the bell away and hitting the two tenders. The one who had opened the clamp died, and the other was severely injured. Unfortunately, the dead tender was not sent to us for autopsy.

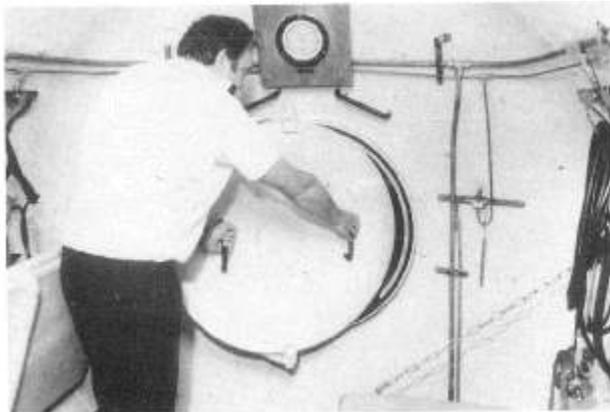
Figure 2 shows how diver 4 probably was about to close the chamber door when the accident occurred. The chamber opening was 60 cm in diameter. Unfortunately, the door jammed (Fig. 3) so firmly that it later had to be cut loose with an acetylene burner. Diver

FIG. 2. The probable position of diver 4 about to close the chamber door.

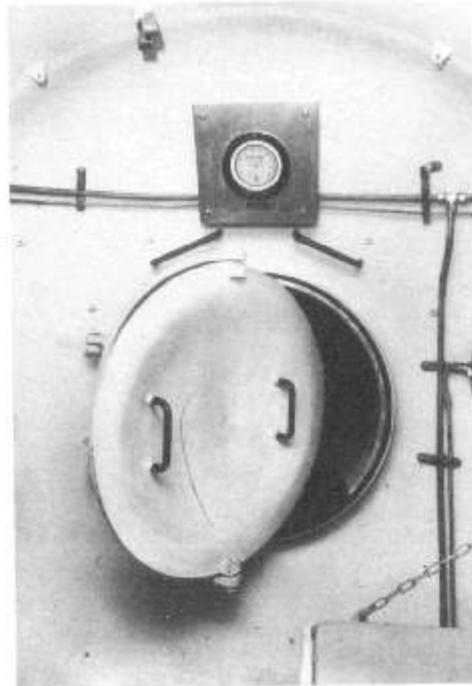
FIG. 3. The approximate position of the jammed chamber door.

It was tragic that the door between the chambers and the trunk jammed as it did. If the construction of the hinge mechanism had been such that the door

would have closed automatically in case of an external pressure drop, these four divers and the tender might have survived!
